## Tavern Clock **Troubles**

A Rare Repair

with Robert Ovens MBHI

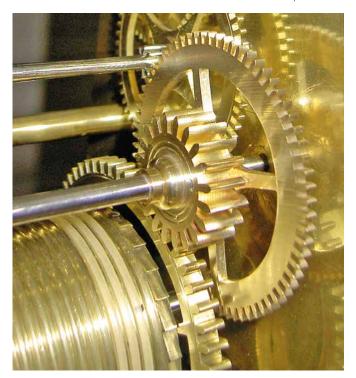
Figure 5. The new 20-leaf pinion and intermediate wheel.

My instinct was correct because when I measured it, it worked out to be 0.7 module. Simple logic told me that it must be the replacement wheel that was wrong, and for all I know it may have come from another clock or other clockwork mechanism. Not having the original wheel can be a dilemma, but in this case, I calculated that a new 72 tooth intermediate wheel of 0.7 module would maintain the centre distance and hopefully solve this problem.

I mounted the new wheel and the new pinion on the original arbor, **Figure 5**, and checked the depthing to the greatwheel and to the centre arbor pinion. All seemed satisfactory and the train ran very smoothly. After re-facing the pallets, bushing the escape wheel arbor and cleaning, the clock ran on test with a nine-pound weight and a good

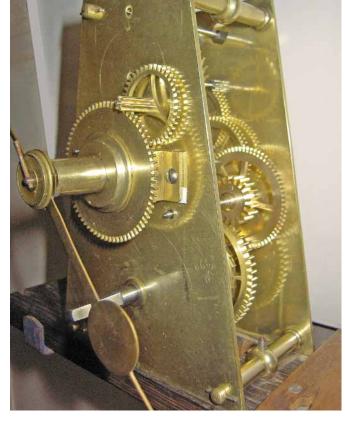
Figure 6. The restored movement.

When a repair like this is carried out, the best advice is to be aware that what is in front of you may not be original – always do your sums! **Figure 6** shows the movement reassembled after repair.
