The Horological Journal

A Justin Vulliamy Chiming Clock

Making New Parts Along with Conservation Work

Jim Arnfield FBHI

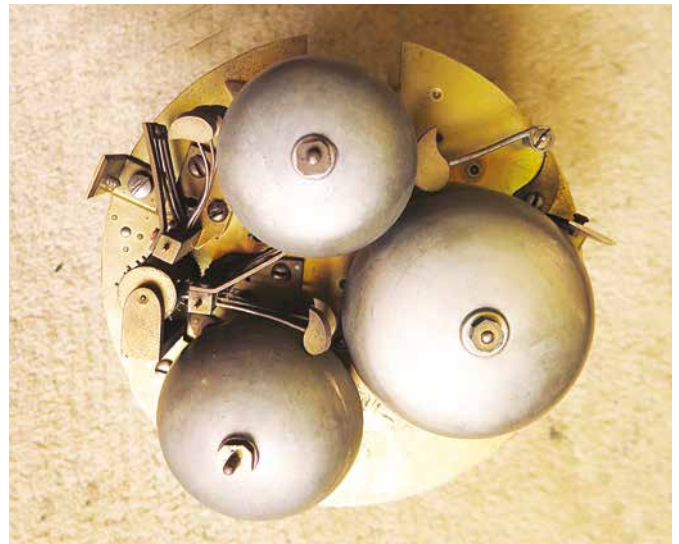
Some months ago, I was asked by a collector to have a look at a movement by Justin Vulliamy with a request to get it into going order, **Figures 1 and 2**. It was fitted into a brass tube in the manner of many eighteenth-century French clocks, with a vitreous enamel dial, glazed bezel and pierced rear door, both hinged on the left, reinforcing the view that it was made to replace the movement in a fine French clock. The long-lasting dynasty of Vulliamy clockmakers is notorious for often having replaced clock movements with movements of their own manufacture, as 'improvements'. The present owner possessed only the movement and had no information about the history. This could be an example of such a replacement. Judging by the filled holes in the backplate, it was probably originally fitted with a verge escapement, and made in about 1780. It is presently fitted with a new, beautifully hand-made platform escapement from about 1850. Although the movement was in generally good condition, the main problem was that the balance was completely missing. All three gut lines were broken, so I knotted the going train line in order to apply some power to the train so that tests could be done.

Figure 1. The movement as received.

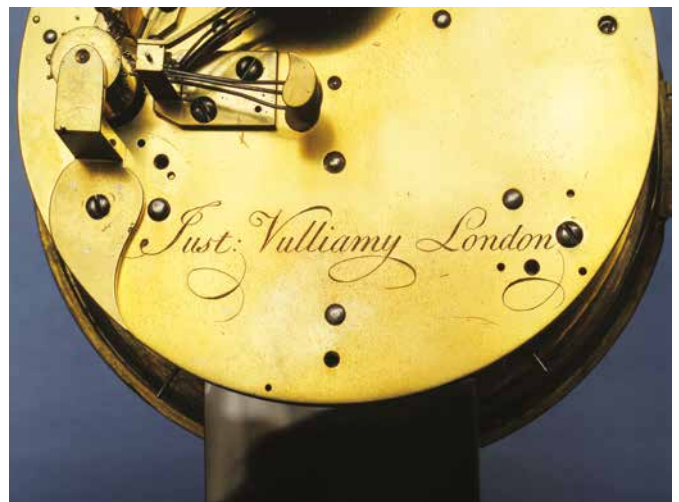
Figure 2. The Vulliamy signature.

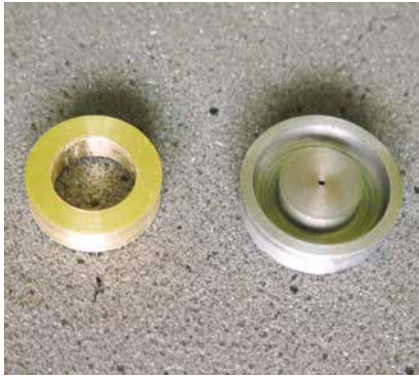
Figure 3. In making a new balance, a slot was turned in the steel disk, to be filled with a melted brass ring.

Work started on a piece of EN8 steel by drilling and boring a small hole in the centre and machining a circular slot to be filled with brass to a depth a little deeper than the rim of the finished wheel. A brass ring was then turned to fit loosely into the slot, **Figure 3**, coated with borax paste, then heated to bright red to melt the brass and fuse it into the slot. The disc was returned to the lathe and the all steel side turned away to reveal the brass, and the steel turned away from the OD. Next, the disc was held on the anvil on edge and then hammered all round to compress and harden the brass, **Figure 4**. Then more turning to finished thickness, diameter and sink out the centre. The balance arm was made by milling excess material from the base with a tungsten carbide cutter in the milling spindle, **Figure 5**. The rim was slit to allow the two segments to move in response to temperature changes, **Figure 6**, and then trued to correct any distortion caused by the stresses of cooling and hammering. The balance staff was made next, followed by a succession of four test rollers necessary to get the ruby pin at the right radius to get a clean

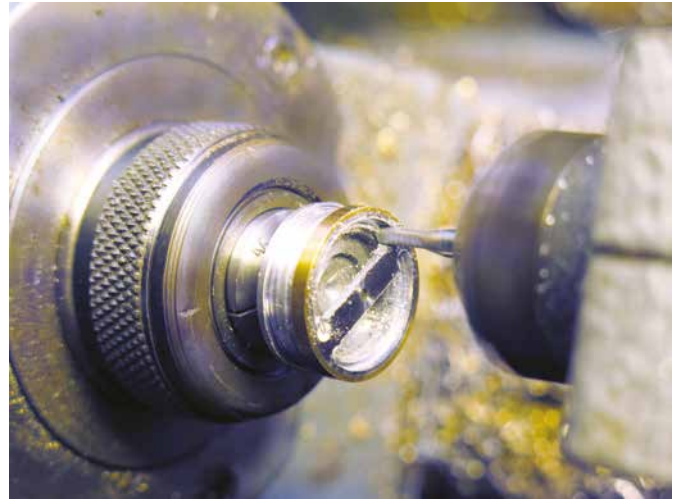
Figure 5. Milling the balance arm.

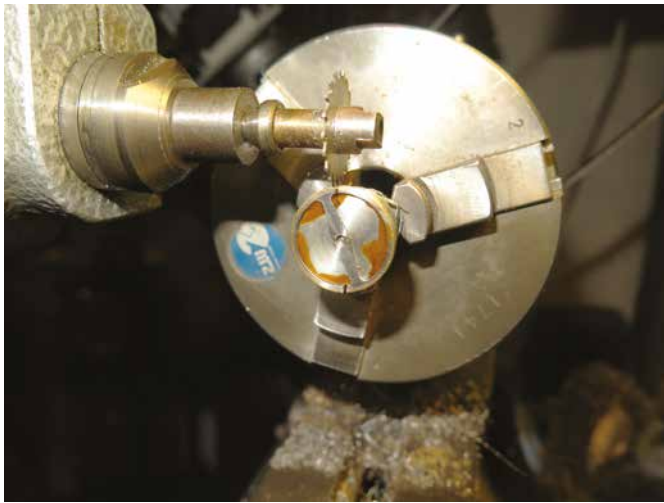
Figure 6. Slitting the balance rim.

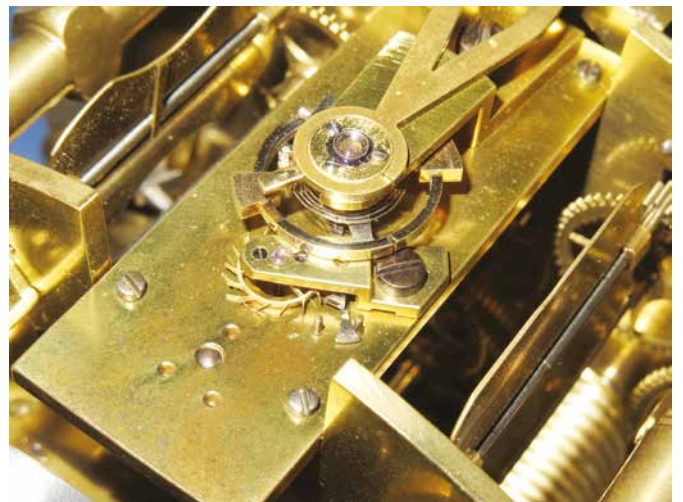
Figure 7. The completed platform.

Now that the platform was working well, **Figure 7**, the movement was completely stripped for cleaning, fixing damage and making other missing parts. Several of the brass springs operating the strike work were either missing or broken and other minor parts were bent. The rack-strike work is not of the usual warning pattern, but has the non-warning 'flirt action' similar to striking carriage clocks. Flirt action generally uses levers that rapidly flick the strike work into action, compared with normal strike work that comes into play fairly slowly. In this clock, one of four pins in the reverse minute wheel contacts the tail of a spring-loaded lever and progressively drives it against a spring. When the pin leaves the tail, the lever 'flirts' up, hitting and latching up the quarter rack hook, allowing the rack to fall on to the quarter snail. The clock sounds all four quarters before the hour is struck. As the quarter rack falls further into the snail at the hour, it contacts a pin on the hour rack hook letting the hour rack drop. The hour train is held until released by a lever moved out of the way when the quarter rack is fully gathered, **Figure 8A**. An interesting feature in the strike work is that the ends of the gathering pallet arbors are threaded to take nuts to secure the gathering pallets rather than drilled for retaining cross-pins or the pallets being a light drive-fit,

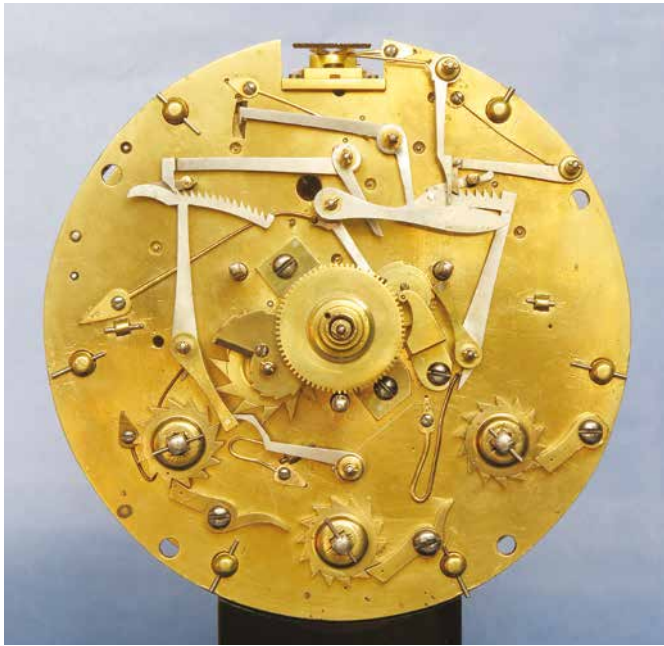
Figure 8A. The under-dial work. Several springs had to be made.

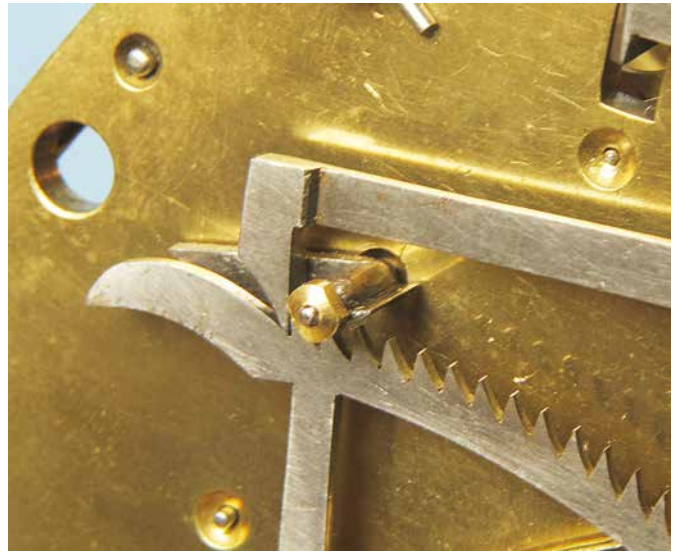
Figure 8B. A close up of the new retaining nut on the hour gathering pallet.

Figure 8B. The nuts were both missing so new ones were made. This top quality movement was generally in very good condition, showing that it had had very little use from new, so minimal attention to pivots and holes was necessary, **Figure 9**. Assembly was very difficult because of the tight spacing of the English-sized components in circular plates of 140mm diameter, and a special tool had to be made to get the centre arbor rear pivot into its hole. The mainsprings were old and possibly original. The going and hour strike springs were re-used, but the quarter spring had a crack near the outer end, so this was re-ended, but proved to be too short to run the clock for eight days. The clock was stripped again to fit a new spring in the quarter barrel and after a few adjustments it runs very well. In a conversation with the owner reporting progress, we discussed how the movement would be displayed. It was agreed that a black Perspex (acrylic plastic) base and mounting, covered by a glass dome, would be constructed to house it.

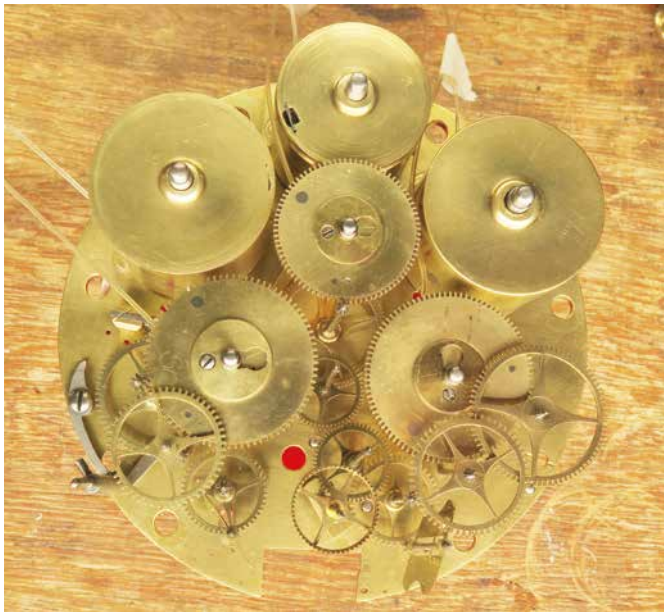
Figure 9. The movement part-assembled.

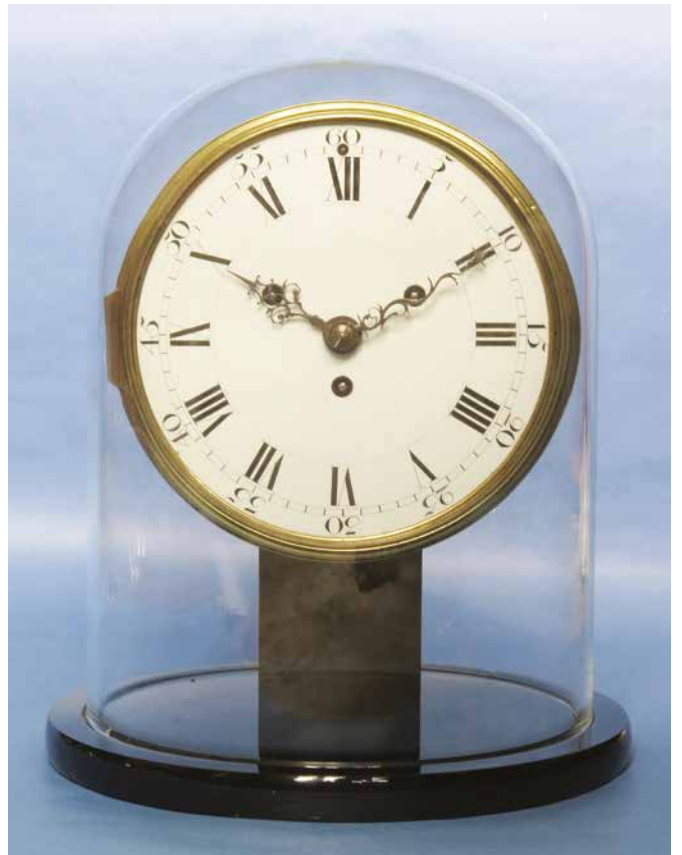
Figure 10. The finished job under its new dome.

the column to take screws fixing the column to the base, and to provide invisible fixings for two brass hooks to hold the movement pillars to the top of the column which was shaped to form a firm seating for the movement, **Figures 10–13**.

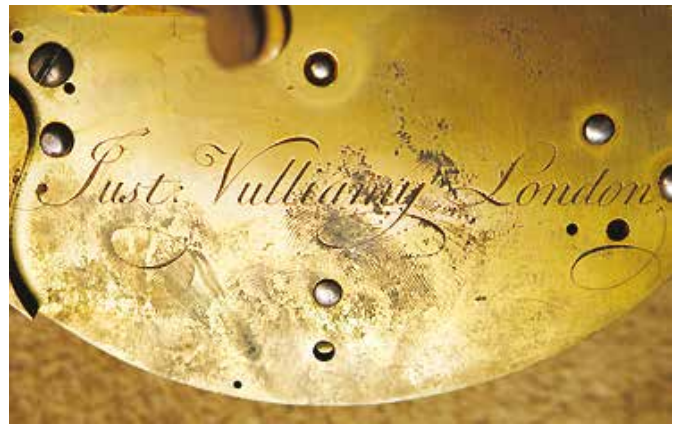
Figure 14. The back plate as received, including heavy fingerprint staining.

As the movement is about 250 years old and in generally good condition, it was decided with the agreement of the owner not to refinish any of the parts, but to clean it conservatively. An exception was the area on the back plate containing the Vulliamy signature which was covered with etched-in fingerprints, **Figure 14**. A minimum of refinishing was done to the plate and some of the etching is still just visible.
