The Horological Journal

Problems with Snails!

New Snails for Two Eight-day Rack Strike Longcase Clocks

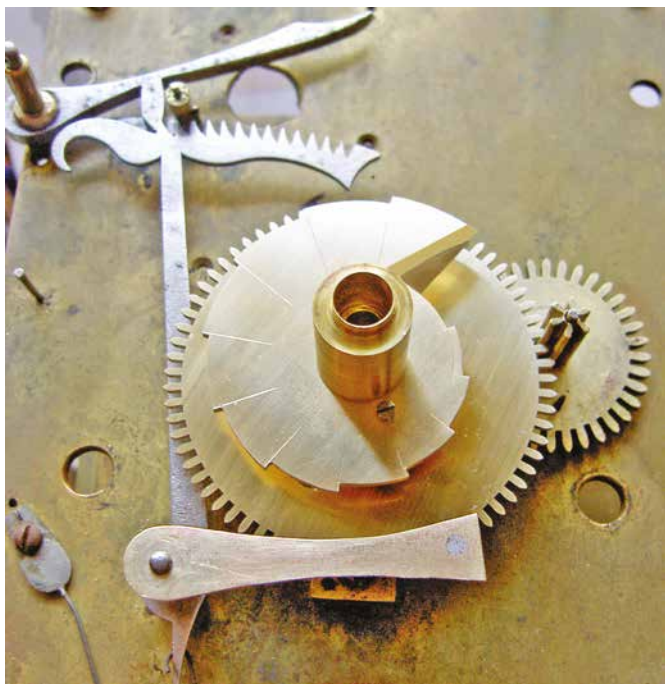
Figure 7. The finished snail.

The last operations were to shape the radial chamfer between the 12 o'clock and one o'clock steps with a file, and to secure the snail to its boss with two 10 BA screws so it can be removed for future cleaning, **Figure 7**. The whole operation took about three hours.

Note that the chamfer is necessary as a safety action, to allow the rack tail pin to slide up and over the snail if the clock

fails to strike at 12 o'clock for some reason. The end of the tail pin must be cut at an angle for this purpose. It is wise to check that this feature works correctly.

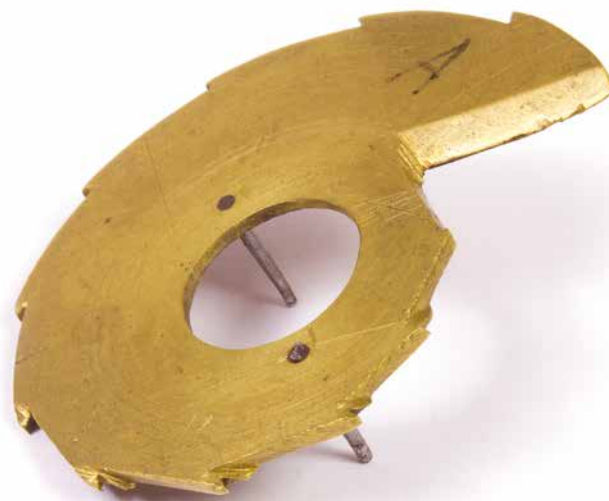
Figure 10. The six to 12 o'clock steps on the old snail had been cut down.

wire and lots of solder, **Figure 9**. However, the repairer did not appreciate the correct geometric relationship between the rack, rack tail and snail or the implications of increasing the mass of the rack tail with several grams of iron wire and solder. As a result, the clock did not strike properly. Rather than make a new rack tail and fit it correctly, the repairer had reduced the snail steps down from six o'clock onwards with a saw in an unsuccessful attempt to correct the problem, **Figure 10**. All the subsequent work was carried out on a

Making the snail was relatively easy as the steps for one o'clock to five o'clock on the old snail were intact, and the one o'clock step provided the radius for the new snail blank. Luckily, the brass scrap box contained a wheel blank of the correct thickness and adequate diameter.

For marking the steps on the new snail, the movement was partly assembled, including the rack and snail along with the gathering pallet and appropriate train wheels. The sharpened taper pin on the rack tail was then used to mark out the steps one by one on the snail directly from the teeth on the rack. The rack and snail now formed a matched pair.

Using a piecing saw, it was then a matter of minutes to cut round the scribed lines, taking care to leave a small margin to be fettled with a fine file. I also shaped the radial chamfer between the twelve o'clock and one o'clock steps with the file at this stage, **Figure 12**. The next operation was to double check the position of the rack tail on the rack, rivet it down firmly and run a very neat fillet of soft solder underneath to make certain it cannot move again. A new pin was made and riveted in position at the end of the rack tail in place of the sharpened taper pin. This was made with an angle so that it can slide up the chamfer on the snail if the clock does not strike at 12 o'clock for some reason.

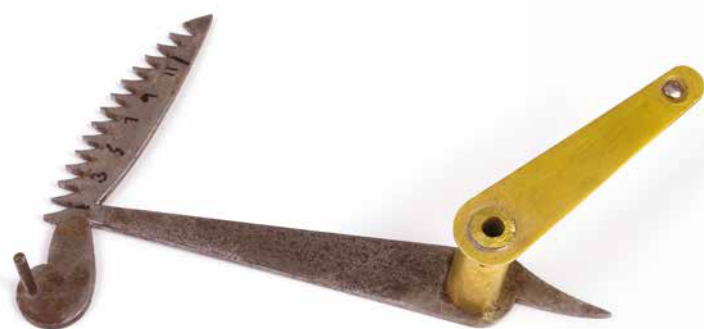
Figure 11. The rack with its new tail.

The next step was to shape a new rack tail out of a strip of scrap brass. The metal was prepared by hammering it to make it springy before cutting it to shape. Its thickness was then filed to a smooth taper for most of the distance between the pipe and the pin. Holes were drilled at each end, one for fixing to the rack pipe and the other to take a taper pin with a sharpened point to be used to mark the profile for each hour step on the snail. The distance between the centres of these holes is the same as the centre distance between the rack post and the centre arbor pivot.

The rack tail was then lightly but firmly riveted to the rack pipe in such a way that it could be adjusted to the best fit when the rack was moved through the hours by the gathering pallet, **Figure 11**.

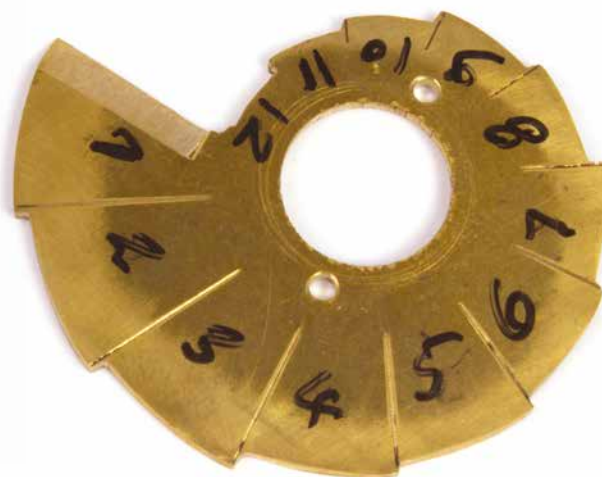
Figure 12. The new snail.

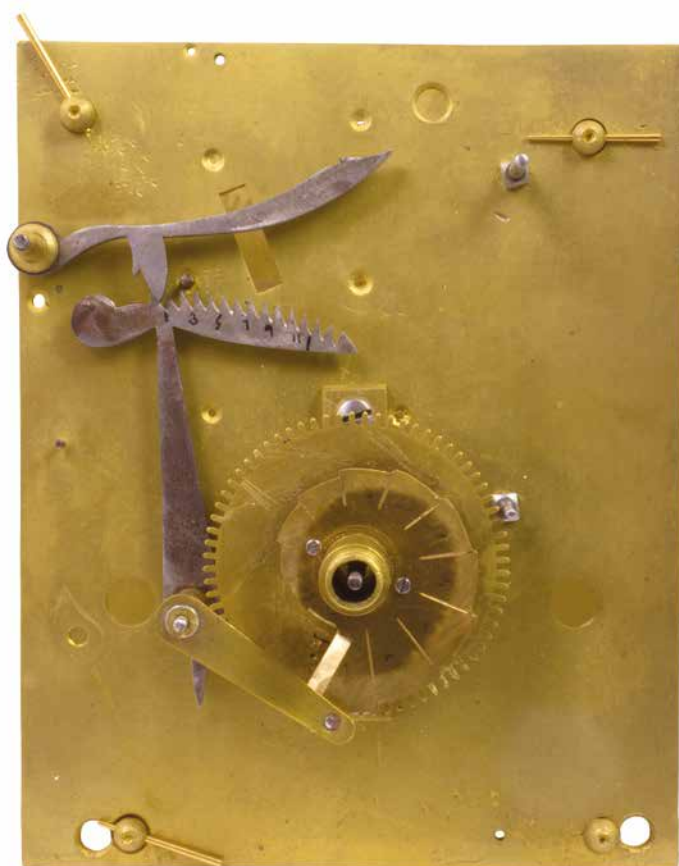
Figure 13. The finished snail and rack tail in place prior to cleaning up.

Finally, I fixed the snail with two 10BA screws to replace

the taper pins that were often used, **Figures 10 and 13**. The purists may well shun this practice, but I have noticed, when working on longcase clocks in the Museum of Timekeeping collection (as part of the Conservation and Maintenance Group I hasten to add), that well-known makers do seem to have used screws to fix the snail as a matter of routine. I feel that this can be only good practice.
