Service and Repair of a Minute-Repeating Chronograph

Mending a Complicated Watch

Robert Horan MBHI

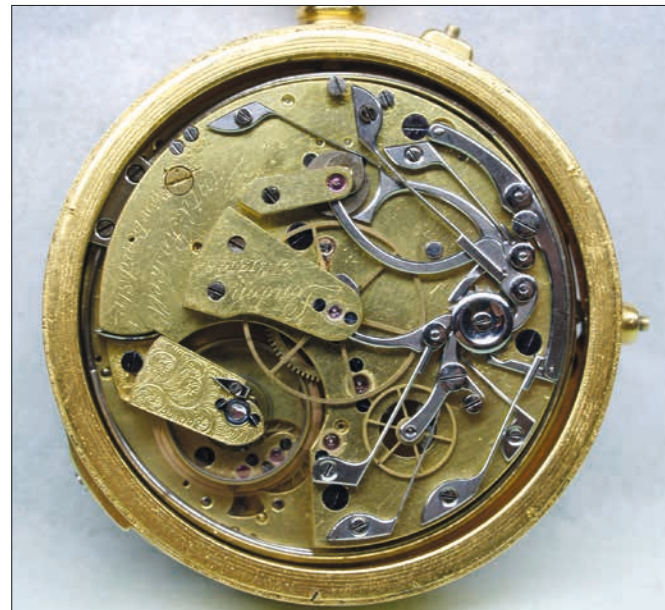
Figure 1.

A minute-repeating pocket watch with chronograph arrived for servicing and repair. The owner stated that although the repeat didn't work, the time and chronograph did. I was looking forward to this because although I have experience with these complications, I have never worked on a watch that combines them all, **Figures 1 and 2**. Typical for minute repeaters, I could not find any maker's marks, calibre numbers, or any other identification that would provide clues as to who had manufactured the movement. I did notice something interesting, though: all the previous minute repeaters I have serviced had the repeat work located above and to the left of the stem. On this one it was the opposite, with the repeat work located below and to the right of the stem.
