# Restoring a Month Going Comtoise

*An Affair to Remember*

John Reynolds FBHI

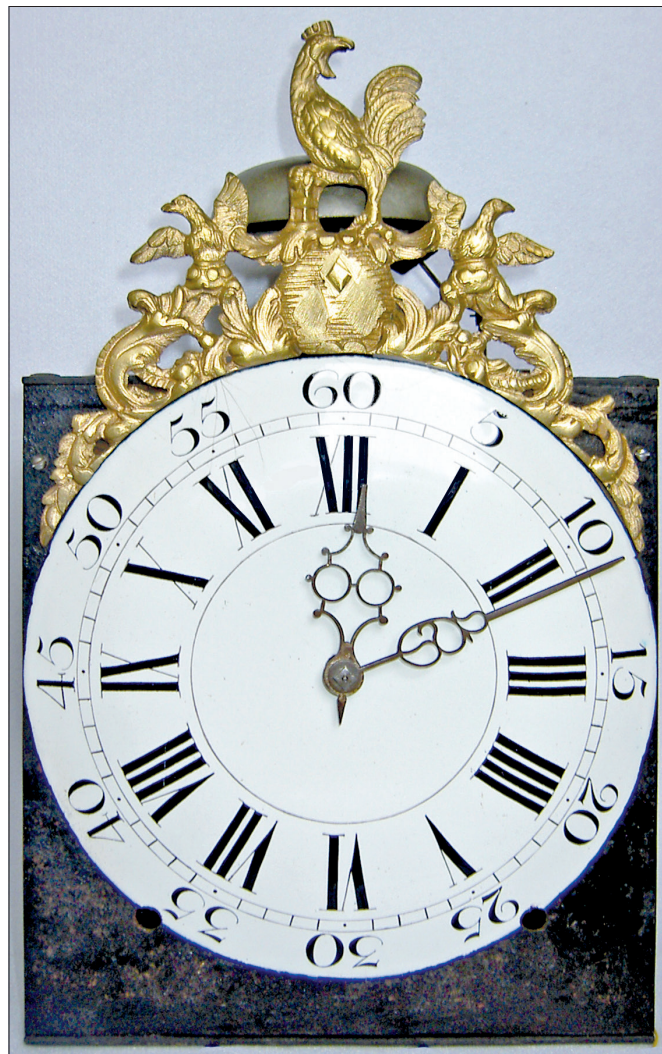
Figure 1. The dial and fronton after cleaning.

The clue to this is that the winding holes just clip the lower edge of the enamel dial, **Figure 1**. This is a normal feature of month-going Comtoise clocks and is due to an extra wheel in the trains to achieve the longer running. I am sure that the seller was not aware of this, otherwise it would have been mentioned in the details. I could also see that the clock appeared to be in reasonable condition and that the dial seemed to be undamaged. There was no signature, but this is not uncommon for a clock of this age with this type of domed dial.

The finely made steel hands, **Figure 1**, were in excellent condition. The small tail on the hour hand suggested that there should be an alarm-setting disc behind the hands and on looking inside, I could see the holes for an alarm mechanism that had been removed. It would be easy to work out what is missing and replace it, but this will be left for another day. There were no filled-in screw holes and the only unused holes were three in the base plate and one in the top plate due to the lost alarm work. All the other screws were marked up for correct refitting after removal. I could also see that the dial was in remarkably good condition for its age. It had a few minor chips in the enamel round its edge and some customary hairline cracks across the face. All were hardly noticeable and all it needed was a clean.

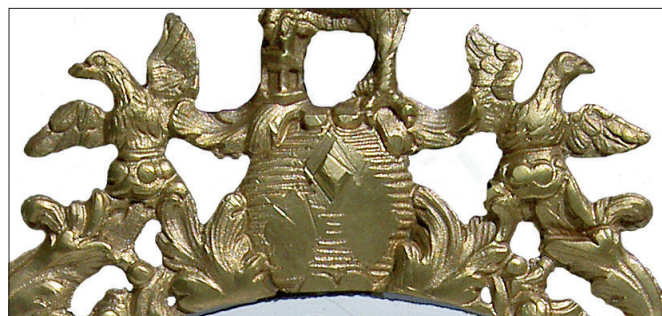
Figure 2. Some of the detail had been removed from the fronton shield.

some of the details on the central shield had been removed, **Figure 2**. They probably depicted the *fleur-de-lis*: the emblem of the kings of France and something which was frowned upon by the revolutionists.

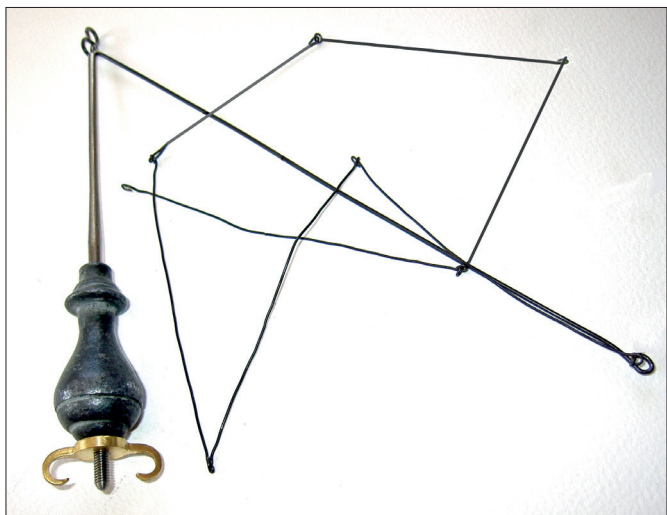
Figure 3. The wire pendulum and bob with a new rating nut.

The thin wire pendulum, **Figure 3**, is rather like a surveyor's chain. It is made up of short lengths of iron wire with a loop at each end for joining to the next length, making it suitable for transportation. It will need re-making, but for now I have replaced the lower threaded section and made a new rating nut as shown in **Figure 3**. It is actually 62 in (1.52 m) from the thread suspension to the centre of the lead bob, confirming that it is a one and a quarter seconds pendulum. With this pendulum length and a weight drop of approximately eight feet (2.44 m) to achieve 30-day running, the clock will have to hang quite high on the wall. Perhaps I will have to settle for 20-day running. They were called month-going clocks, but 20-day clocks would probably be more accurate.

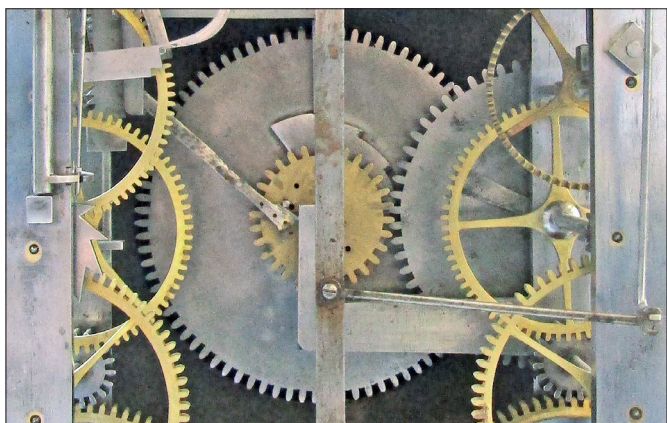
Figure 5. The iron intermediate and hour wheels without crossings.

An excellent reference for those interested in these clocks is *Comtoise Clocks; The Morbier; The Morez* by Francis Maitzner and Jean Moreau (English edition published by Stampa, Dombasle, France. 1991).<sup>\*</sup> This has a guide to dating Comtoise clocks and several features are helpful in confirming a late eighteenth century date for this clock. As well as the cast brass fronton, they include the style of the hands, the thin wire foldable or collapsible pendulum rod, the tall rear suspension support with a thread suspension, and the iron intermediate and hour wheels without crossings, **Figures 3–5**.

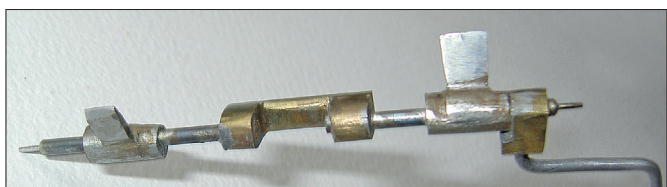
Figure 6. The pallet arbor with short pallets that came with the clock.

Inside the movement, it was clear that an attempt had been made to replace the lost or broken verge pallet arbor, but there was little chance of it working, **Figure 6**. The pallets were too short and the potence had been bent down more than I would expect to try to bring the verge escape wheel into deeper engagement with the pallets, but this had not been successful. It was obvious that a new pallet arbor would have to be made and I decided this would be my first task.

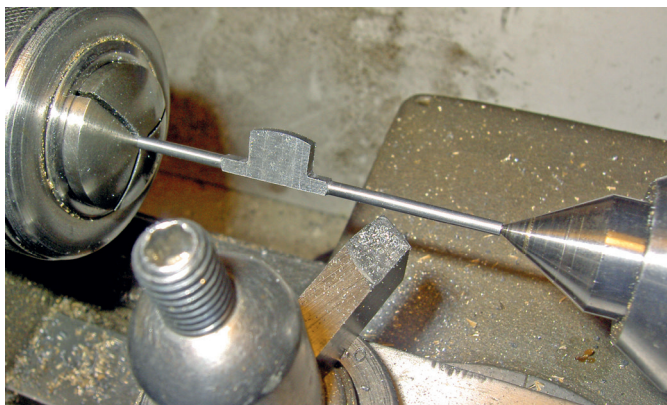
Figure 7. Turning the tapered pallet arbor on the lathe. The central gap was cut out after this operation.

The pallet arbor was made in one piece from 2 mm gauge plate. This was cut to shape to create the block for the central gap before turning on the lathe, **Figure 7**. The separate pallets were also made from gauge plate and for accuracy each was drilled on the lathe using a four-jaw chuck, **Figure 8**, before being hand-filed to shape.

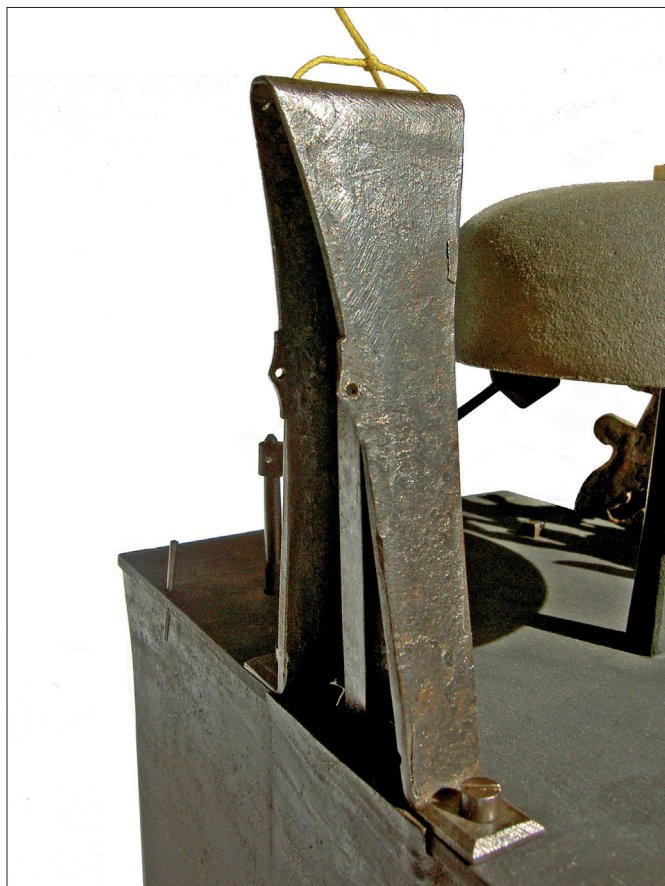
Figure 4. The tall suspension post for the rear pendulum. The rear cover, removed in this photo, is held in place with one long pin through the two holes.

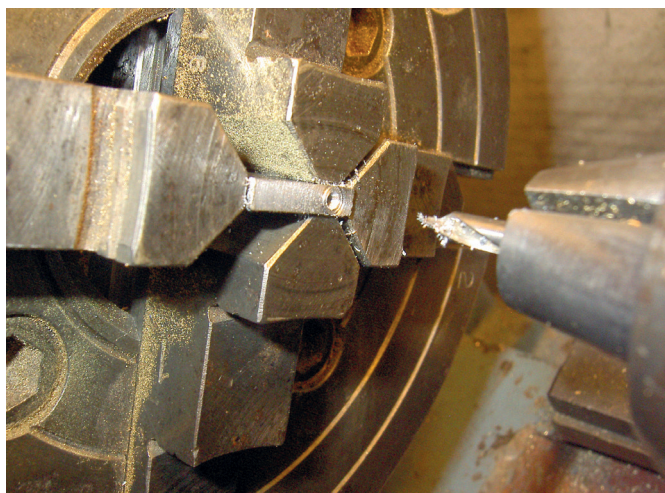
Figure 8. Drilling one of the verge pallets in the lathe.

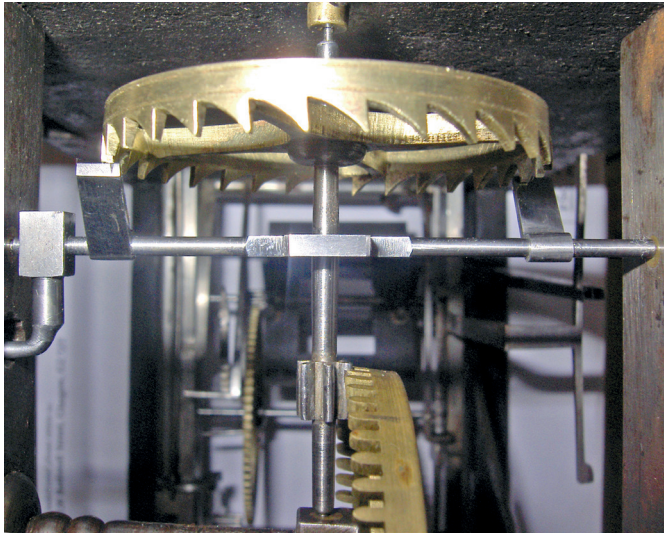
Figure 9. The finished pallet arbor in the clock.

After straightening the potence, I placed the crown wheel and the new pallet arbor in the movement. Leaving the pallets not too tight on the tapered arbor, it was possible to bring them to the correct included angle of about 70° and to check their length as well as to examine the action. This was not an easy task. The pallet tips were then hardened in the usual way, leaving them glass hard, before being polished. The arbor was then returned to the movement and the pallets set to the correct angle, **Figure 9**. Outside the movement, with a support in the gap, the pallets were tapped on tight using a hollow brass punch.

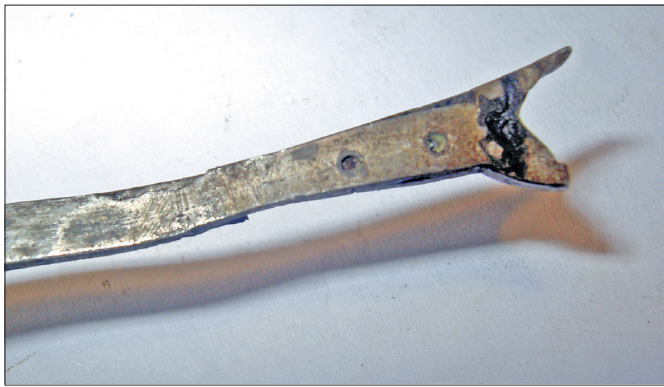
Figure 11. The detent with the added doe's foot.

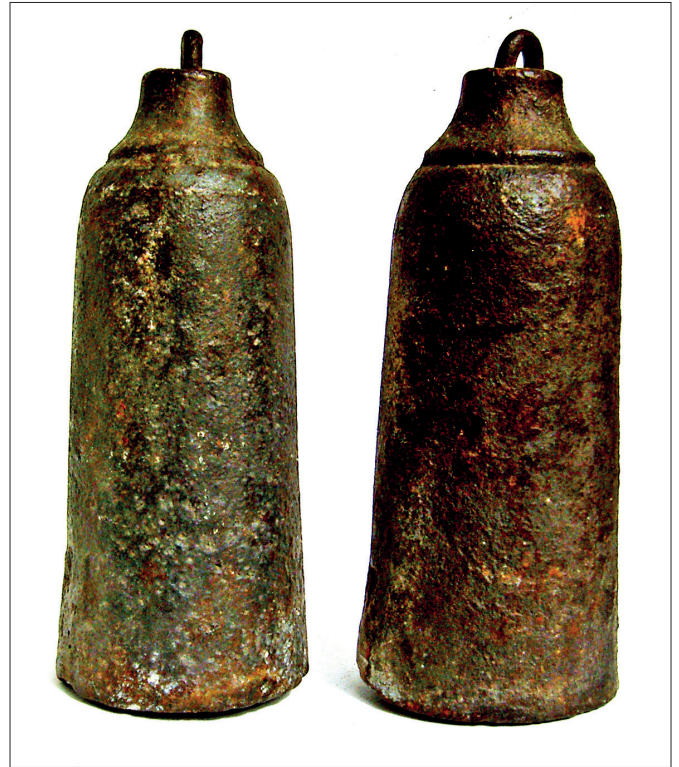
Figure 10. The traditional Comtoise weights which were acquired for the clock.

On completion of this task, the wheels and other components were cleaned and the going train assembled ready for a test. It ticked quite well on one of the 5 kg (11 lb) Comtoise weights, **Figure 10**, which my French contact acquired for me, but a little heavier would be better. This was an excellent result for a month-going movement.<sup>†</sup>

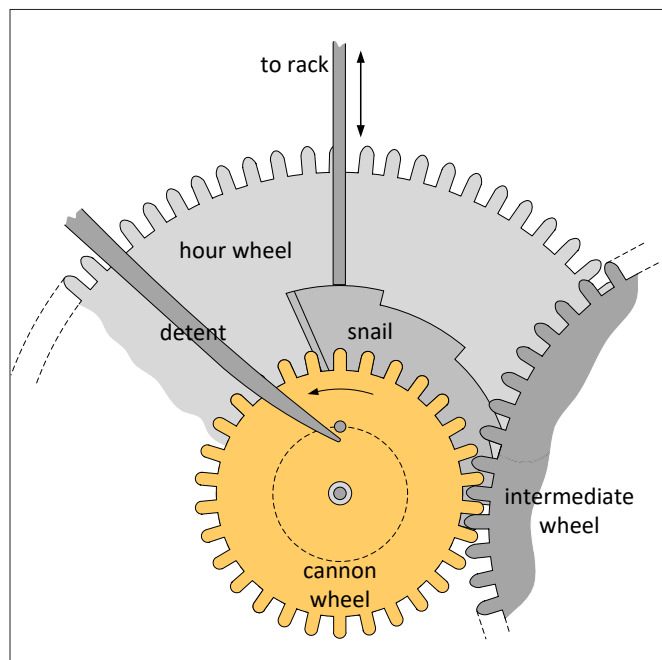
Figure 13. A rear-view drawing of the motion work showing the arrangement for hour striking only.

I could also see that there was a second pin on the cannon wheel which might cause the clock to strike the half-hours, although its location was suspect. Some month-going Comtoise clocks have a passing strike with a separate bell hammer for this function, but there was no evidence of this on the clock. Judging from the poor state of the 'doe's foot', **Figure 11**, grafted to the end of the detent and the number of holes for let-off pins in the cannon wheel, **Figure 12**, it seemed that several attempts had been made to convert the clock to half-hour striking. In the event, I decided that half-hour striking was not an original feature of this clock because, again, the additional drop of the weight would be unacceptable.<sup>‡</sup> The tip of the detent should therefore be straight without a doe's foot, **Figure 13**.

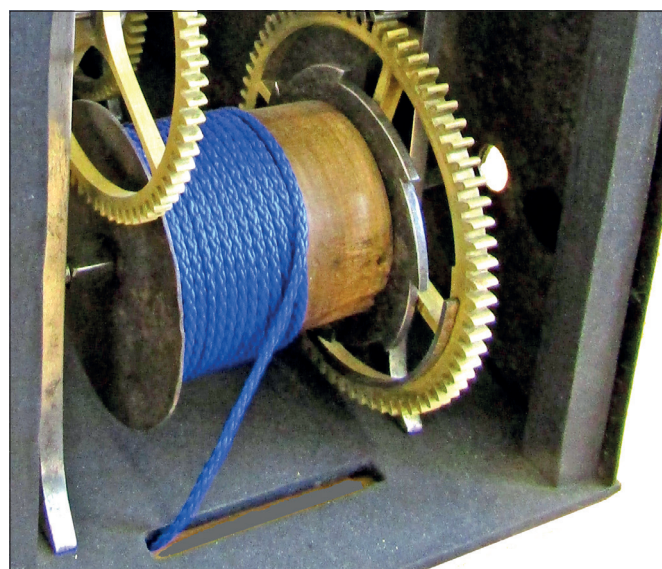
Figure 14. The barrels had been converted to fill from back to front.

both barrels, indicating that they originally filled from front to back. When I first inspected the clock, I noticed that the line fills the barrels back to front, **Figure 14**.

With this arrangement, fitting a new cord is easier as the back flanges can be removed without dismantling the movement. Restoring to original would mean having to move the wooden barrels away from the ratchet wheels, but they appear to be extremely tight on their squared arbors. I decided to leave them as they are to avoid any damage. This revised fill direction also means that the weights now start their fall as far away from the pendulum as possible.

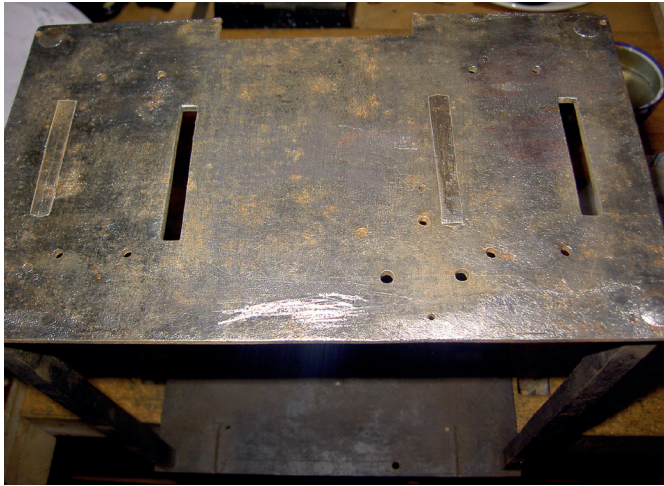
Figure 15. The bottom plate before painting, showing the filled weight line slots and the vacant alarm work holes.

This process revealed that two weight line slots had been quite skilfully filled, **Figure 15**, suggesting that the cage was originally intended for an eight-day clock which would have had winding in the opposite direction. The cage doors, which are a matched pair and look original, have catches like those on a lantern clock. However, on the time side the catch is in the way of the intermediate wheel and cannot possibly fasten on the front post. Turning the door upside down so that it latches on the back post solved this problem.

Cleaning a Comtoise is much the same as any other clock except that there is more steel involved. In this clock, the iron cage needed wire brushing to remove the flaked paint and rust. The bottom plate was particularly rusty, and to remove it I soaked it in a shallow tray of vinegar. This was remarkably successful.

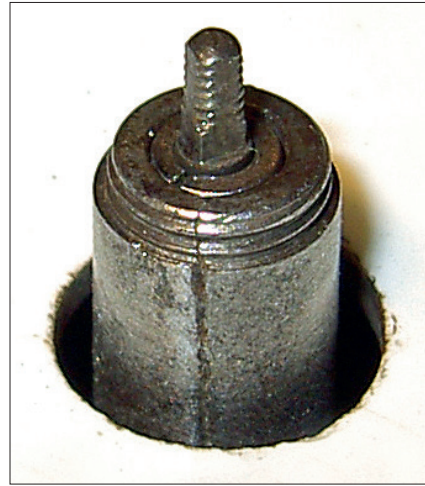
Figure 16. The thread on the nose of the steel hour pipe.

Interestingly, there is a remarkable single turn thread on the nose of the steel hour pipe, **Figure 16**, on to which the hour hand screws. This thread continues right up to the shoulder and I cannot envisage how this was made. The hour pipe itself is also interesting as it appears to have been forged into a pipe from a flat sheet. What looks to be a crack along its length is actually a joint line. It seems to be threaded or riveted into the snail at its rear end, but I did not remove it; if it failed to go back correctly the hour hand would probably not line up with the chapters.

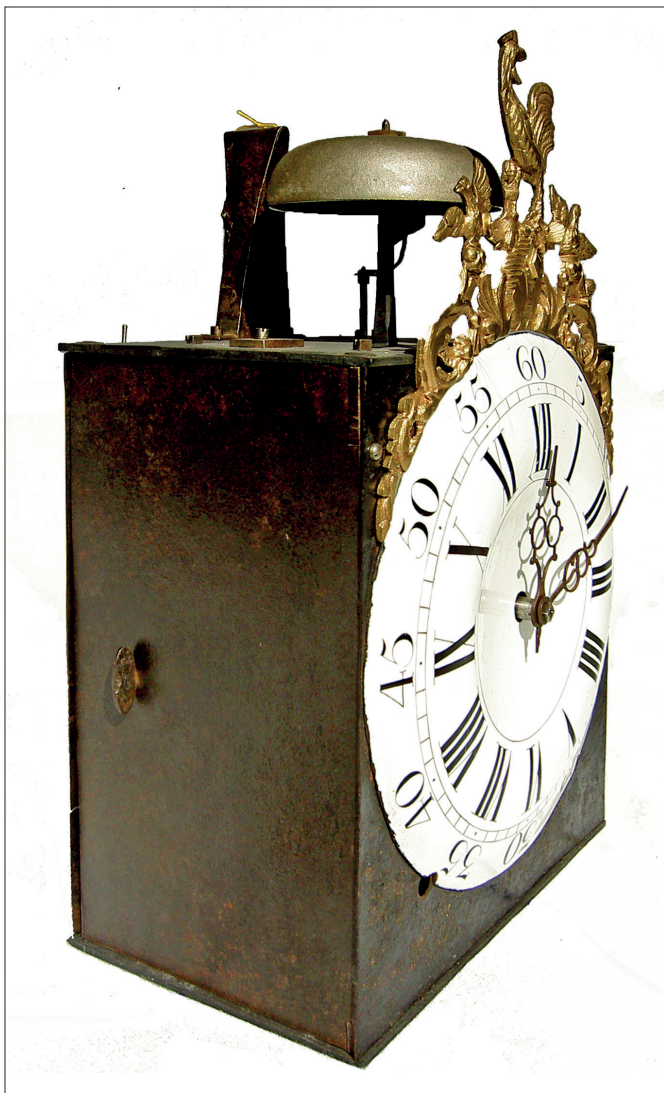
Figure 17. The front and rear plates and the doors were cleaned but otherwise left in their original state.

After removing the flaking paint, rust, and congealed oil from the cage, I finished it with matt black paint which seems to be the standard for all Comtoise clocks. The front and rear plates and the doors were cleaned but otherwise left in their original state, **Figure 17**.

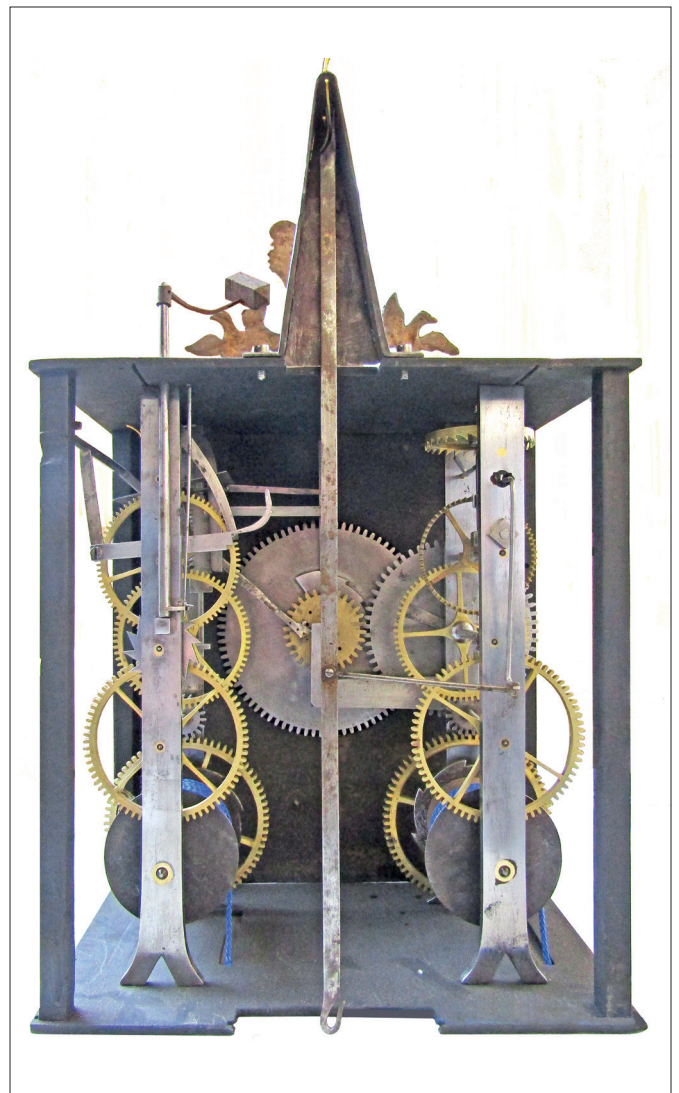
Figure 18. The rear view with the doors, plates and bell removed, showing the side-by-side trains, the extra wheel in the trains to achieve 30-day running, the link between the crutch and the suspension leader, and the tall suspension support.
