# The Horological Journal

# Rare Bentley Earth Clocks

## *A Pair of Pre-Patent Electric Clocks Brought Back to Life*

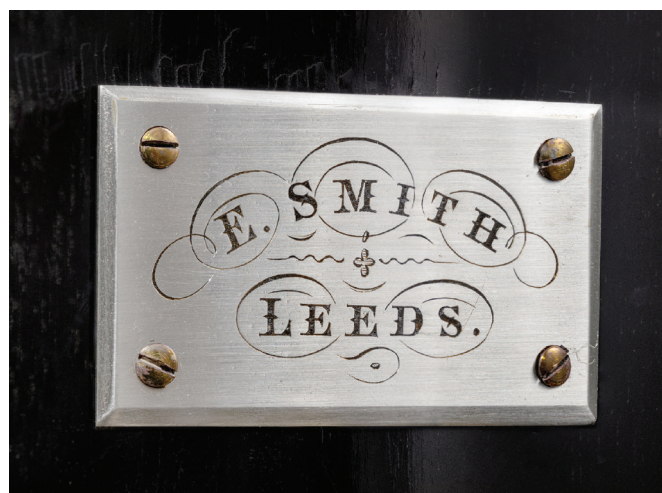
Figure 1. Silvered plate likely inscribed with the retailer's name, inside Clock Two.

Moving the story on to recent times, I received a phone call early last year from the owner to ask whether I would like to get them into running condition. After some discussion I agreed to examine them and report what I could do to achieve his aim. The clocks were delivered and carefully re-examined. This revealed that they were similar to Bain's design, but they must be much later because the construction used many BA threads which were first brought into use in the 1890s, 50 years after Bain's work. Clock Two (the clock with the undamaged case) has a silvered name plate, probably for a retailer, engraved 'E. Smith Leeds', **Figure 1**.

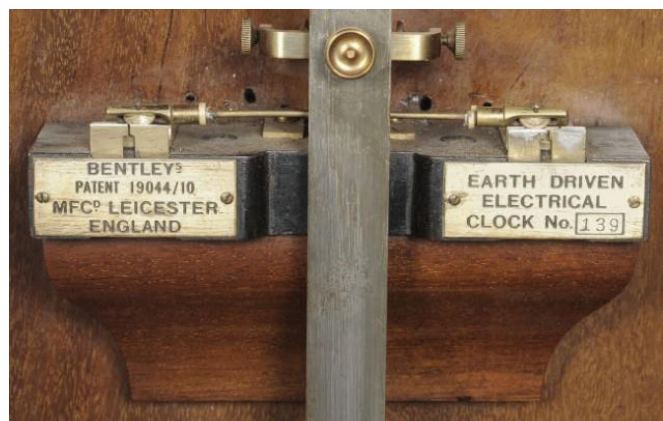
Figure 4. A later trolley contact clock with Bentley labels.

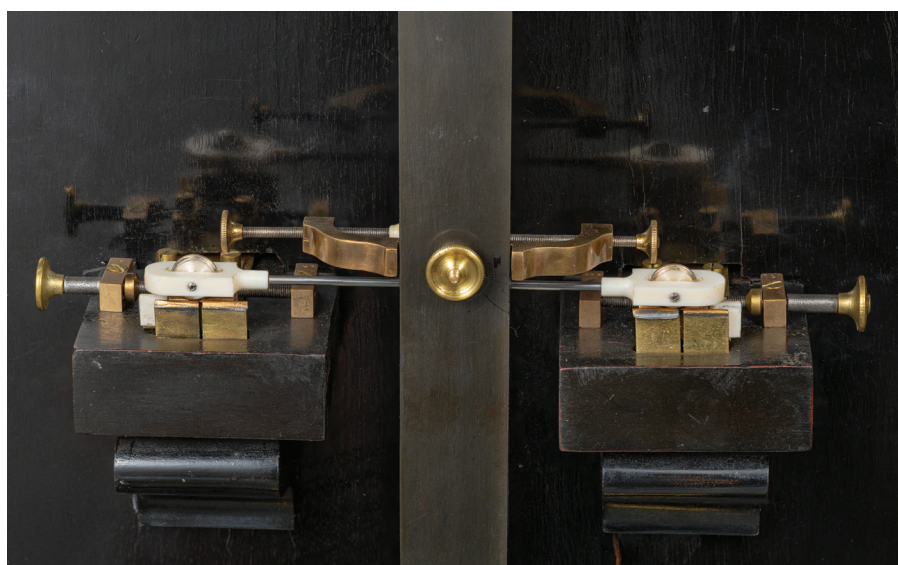
Figure 8. Clock One with original, if somewhat temperamental electrical contacts.

The twin contact assembly is arranged to reverse the current to the pendulum coils near the end of the pendulum's swing, **Figures 7, 8 and top view 9**, so the centre magnetic pole of the coil is attracted to the approaching permanent magnet pole and repelled by the other. This is achieved by having what in the Bentley patent is called a jockey carriage, or trolley, **Figure 10**. This consists of two insulated metal wheels mounted tandem fashion at the same distance apart as the gap between the cross-connected front split contacts. The position of the rear contacts is sideways adjustable by a screwed rod, and each has an insulated section at its outer end. This disconnects the current when the trolley wheels move on to it at the end of the swing and is how the pendulum amplitude is controlled when using an earth battery.

Both cases required much work particularly Clock One, the curved top to the door of which was broken and of very thin section. Some re-making was necessary so the metalwork of both clocks was removed and the cases sent off to a casemaker. When the cases were returned everything from case one had a preliminary cleaning and was replaced so that experiments could be started on trying to get the clock running. This proved very difficult as the contact track was uneven and as the jockey carriage ran to and fro along the track it frequently fell off.

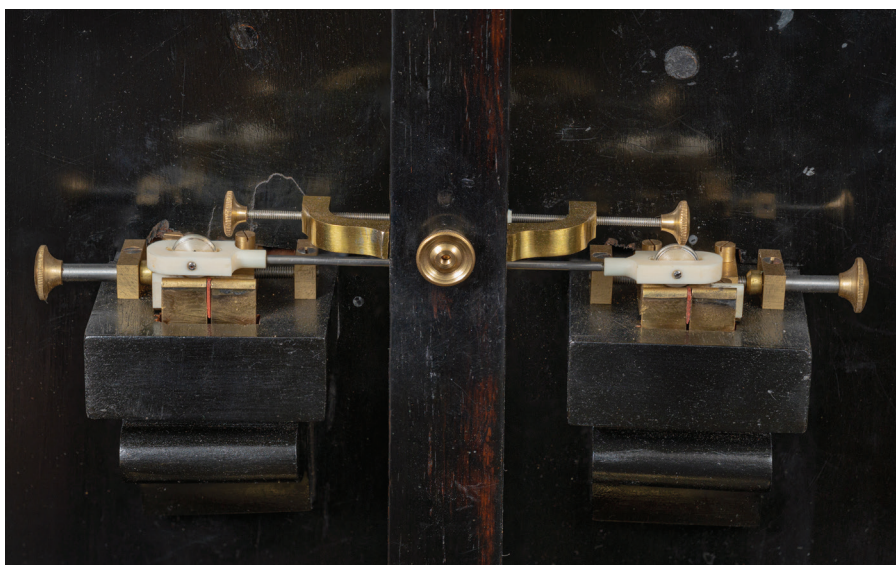
Figure 9. Clock Two; much of the contact assembly was missing. The replacements were made longer by about two millimetres to prevent the trolley running off, as sometimes experienced with Clock One.

After many dismantlings and adjustments to the track I gained enough experience to start work on making a completely new contact assembly for the other clock. I decided to make the new contact assembly 2 mm wider than the original. The reason was that Clock One still had problems; if the pendulum amplitude increased by a small amount then the trolley would run off the end of the track. Also, as USB phone chargers are readily available at very low cost the decision was made to use these to power the clocks. A variable resistor

Work then started on making the replacement contact assembly for Clock Two. I had asked the casemaker to copy the wooden brackets and the blocks to which the contacts are fixed. When the cases were returned Case Two was ready for the newly made wider contacts which had otherwise been

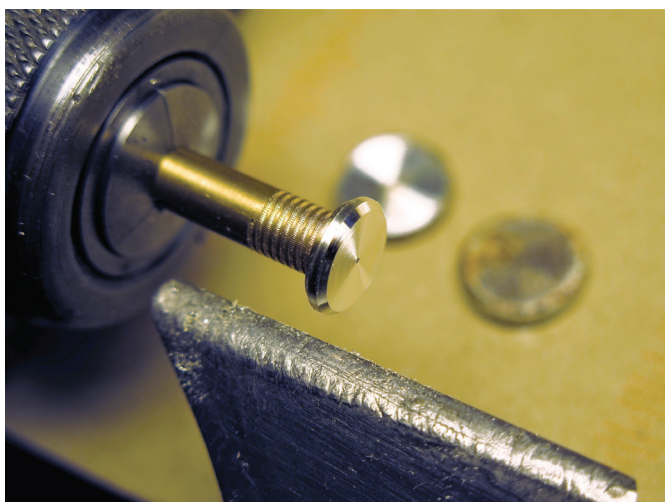
Figure 12. Turning the button to size, in the background one button hammered flat, the other part turned.
