# The Horological Journal

# Omega 'TV Clock'

*How Was It Used?*

Justin Koullapis FBHI

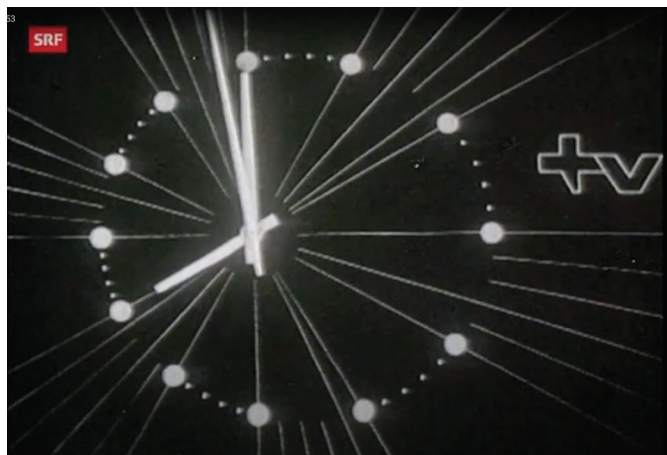
Figure 2. An example of this type of clock as used on the Swiss news programme *Tagesschau/Téléjournal*. Taken from a recording of a contemporary broadcast.

I searched for this exact clock in old TV footage online. The closest I could find has a different emblem on the dial, appearing in a 1960s edition of the Swiss *Tagesschau/Téléjournal*, **Figure 2**.

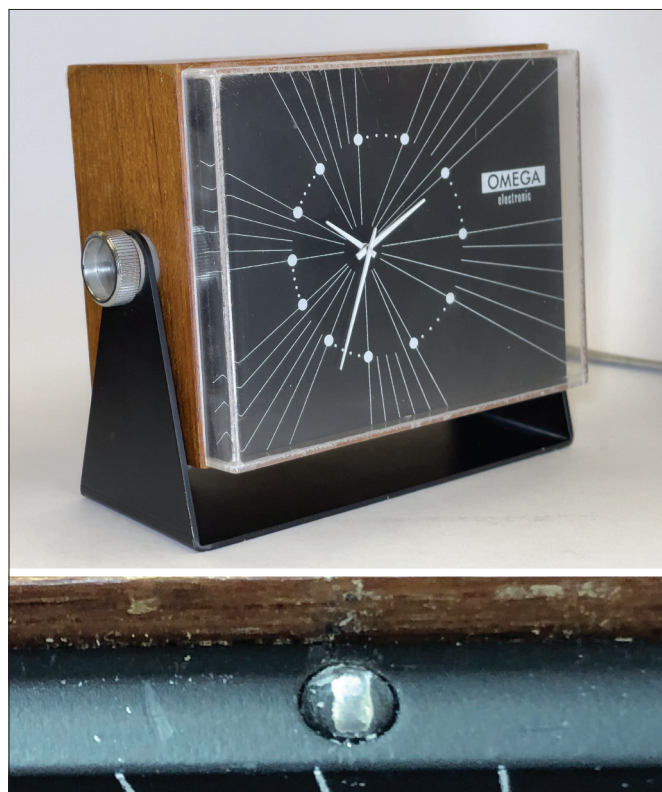
Figure 3A (Top). Detail of the acrylic cover, which will have been removed before filming.

Figure 3B (Bottom). One of the three pins used to retain the acrylic cover.

acrylic cap, **Figure 3A**, sprung on by its own tension over two metal pegs above the dial and one below.

This cover fits snugly but can be removed by gently easing it over lower peg. A small amount of wear is visible here on the peg and in the acrylic, **Figure 3B**. It is hard to tell how much the clock has been used, but there are signs of wear. Overall, this little clock has survived in beautiful order.

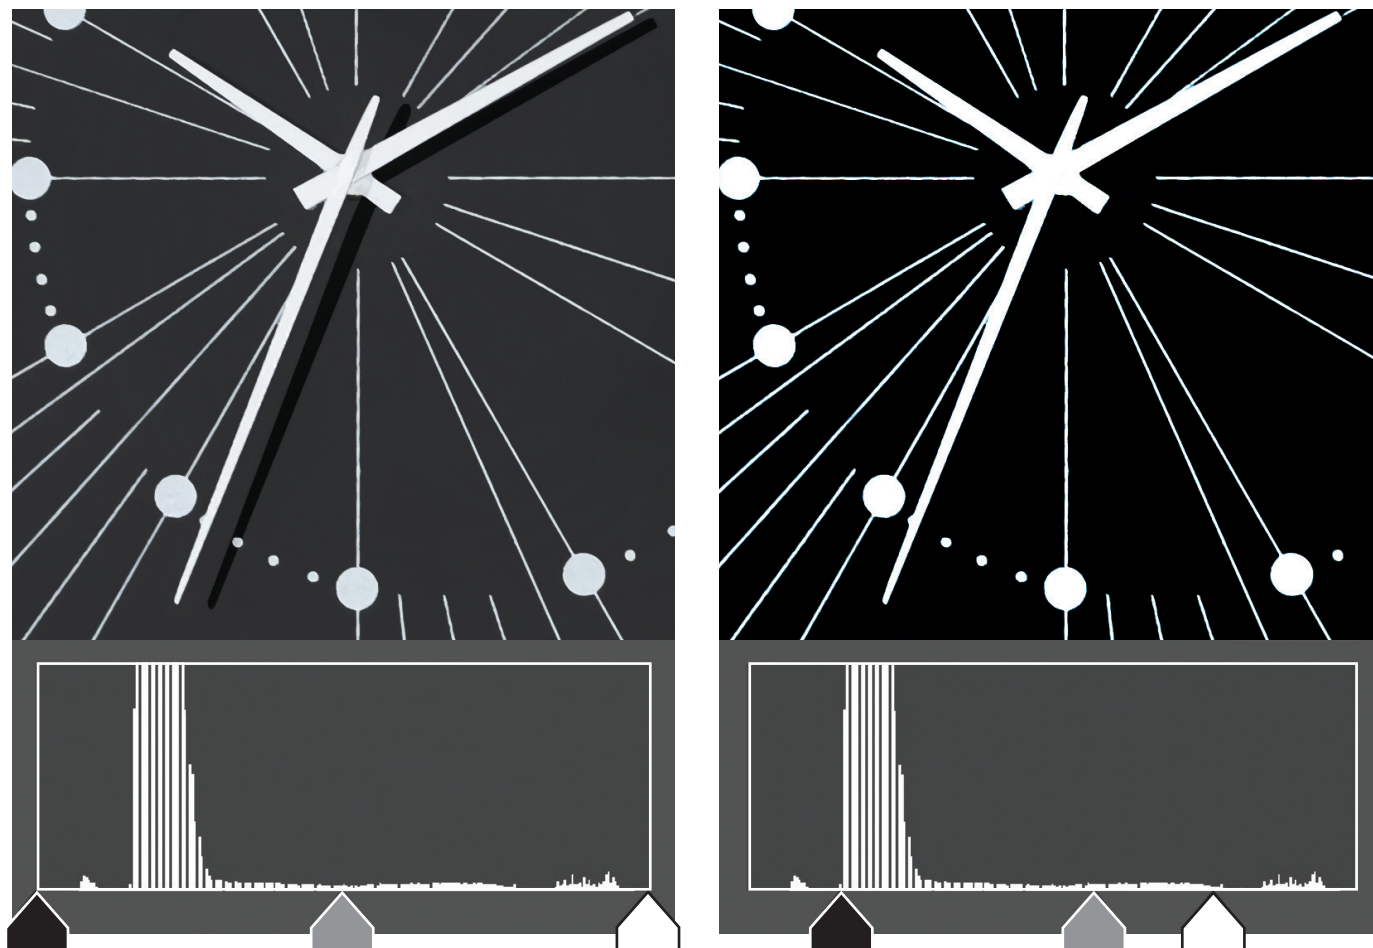
Figure 4. Illustration of how adjustments made to the black and white points of an image can be used to eliminate shadows. This contradicts the published idea that shadows were eliminated by the use of matt paint.

In **Figure 4** (overleaf), I have attempted to illustrate this principle, using a sequence of images showing how dark areas of the dial can be adjusted to pure black and the light areas to pure white. This was done by altering the black and white points of the image in Photoshop. To be clear, these only show the principle, not the same mechanism by which it was done in a TV studio.

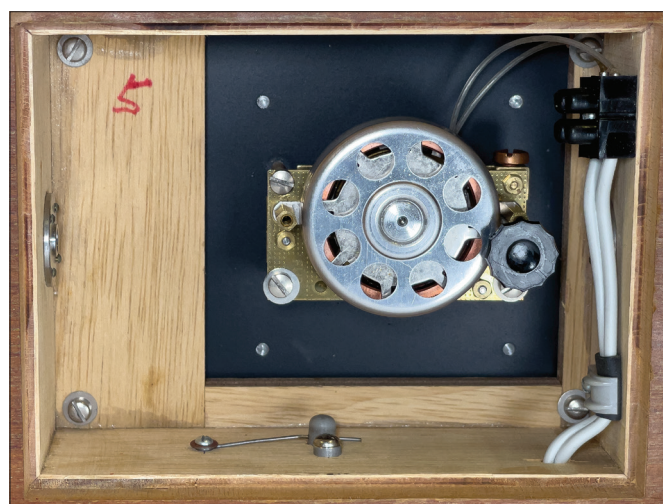
Figure 5. Calibre FU 6, with mains synchronous motor, as installed in the clock case.

When I first received the clock, I tested the mains lead for continuity and short-circuits, and then plugged it in. Everything was fine. Accessible from the rear is a simple setting set arbor, and the armature of the synchronous motor, **Figure 5**. With the clock unplugged it is tempting to give this chunky ‘flywheel’ a whirl. I was studying the clock, spinning the motor whilst watching the action of the hands.

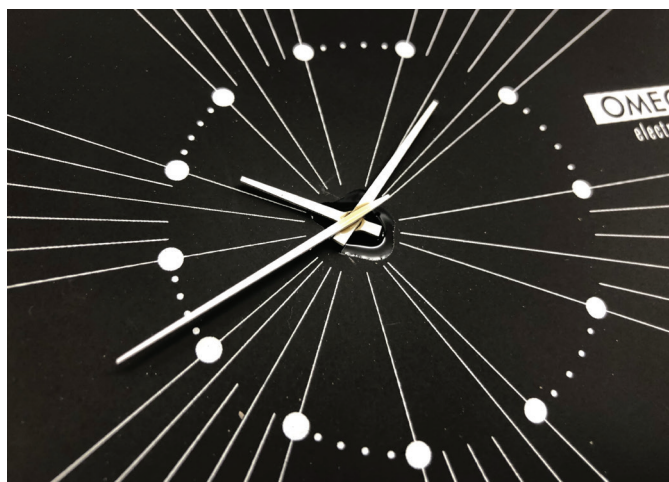
Figure 6. A large blob of old oil suddenly appeared on the dial, having migrated from the over-oiled movement through the motion work pipes.

This is when disaster struck. A huge blob of oil appeared on the dial through the hand aperture, **Figure 6**.

As somebody who spends his life judging watches based on the originality and condition of their dials, this was nothing short of a tragedy. The dial’s matt finish also suggested that the oil stain would be profound and permanent.

Rescue, or at least damage limitation, was urgently needed. First, the movement needed to come out immediately to stop any further oil migrating to the dial. Immediate action would also limit the amount of oil wicking along the matt surface.

How to remove the hands? I did not want to add to the problem by risking marking the dial with a lifting tool or levers – I had not the time to sort out suitable plastic dial protection. I decided to pluck the hands off quickly using my fingertips and nails; this would avoid any contact with the dial. This was difficult, because the seconds hand was extremely tight. By being assertive, I was able to lift the hands straight up off their arbors, without any damage.

With the hands thus removed, I detached the motor leads from the terminal block, and then three screws that held the movement to the back of the dial. My next move was to take a few good photos of the dial with my phone. I kept the images as straight on and square as possible, thinking that if the worst happened, I would at least have a good artistic reference by which the markings may be able to be recreated.

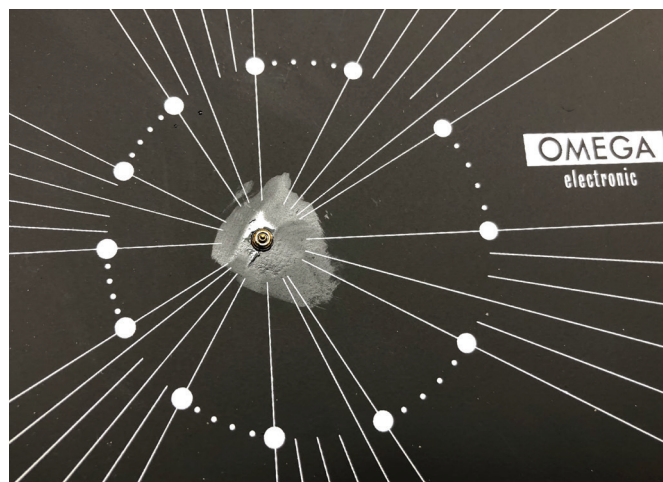
Figure 7. After removing the hands, excess oil was dabbed away, before removing the movement so that rapid intervention could be applied.

Viewed from the dial side, it became apparent that the movement was absolutely dripping with oil. I dabbed excess oil from the front and rear of the dial, **Figure 7**, and then set to it with warm water and washing-up liquid.

This was a calculated risk; it seems likely that a dial will have been painted with enamel paint, and therefore not water-soluble. Even if it were, by working quickly, risk of paint loss was reduced.

As I washed the dial it became clear that the paint was secure. Thank you, Omega! I proceeded to wash gently and evenly over the whole surface. I kept the water fairly warm but

not hot, because differential expansion of the thick aluminium dial vs the black paint may have caused flaking. Afterward, I patted it with a clean towel and then blasted it with a low-pressure air jet at my bench. From the time I noticed the blob to getting it under the tap was about five minutes.

There is now an almost invisible residual evidence of the oil mark, perhaps 2% off the surrounding background, if one can put a number to a subjective assessment.

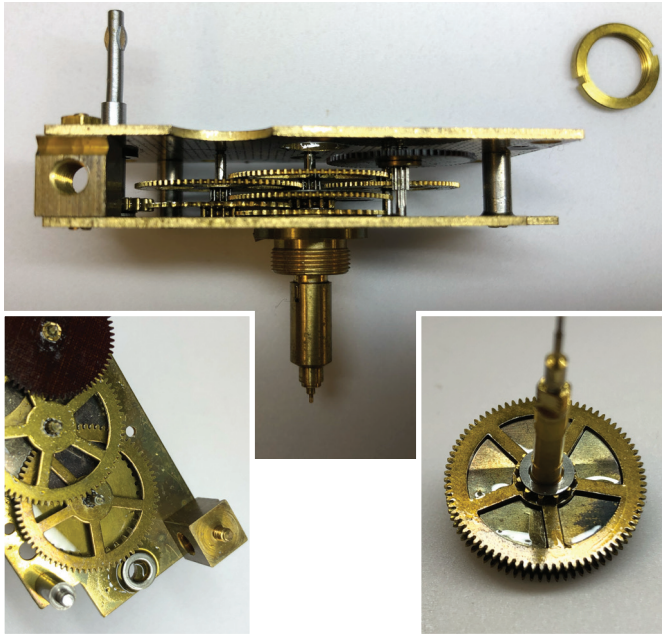
Figure 8A-C. The calibre partly dismantled, also showing the extreme excess oil.

I have to ask, why was there so much oil in the movement? I was cross with myself for fiddling with the motor before looking at it more carefully, but it would have been very difficult to detect the oil while the movement was still in the case. I was also cross with the unknown previous owners – I later asked the vendor if he had the clock serviced before sale, but he had not, meaning that the oil had been there a long time. Either some well-meaning soul had given the clock an occasional top-up, as one sadly often sees, or was it perhaps heavily oiled on purpose so as to damp the motion of the hands and give a more gliding action on-screen? **Figures 8A–C** illustrate the quantity of oil, along with a general view of the movement layout.

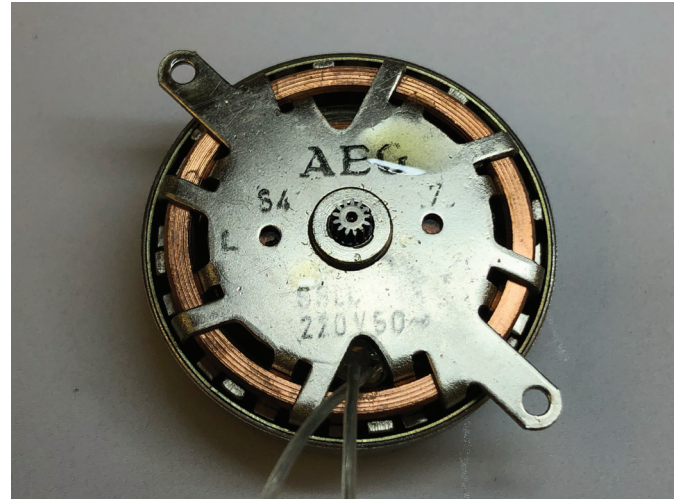
Figure 9. The AEG mains synchronous drive motor.

The calibre FU 6 is straightforward, but there are a few interesting details. The little motor was made by the German firm AEG. This assembly is pressed together, so I cleaned it as best as I could from the outside. There was a lot of oil on the outside, but I couldn't detect any within, **Figure 9**.

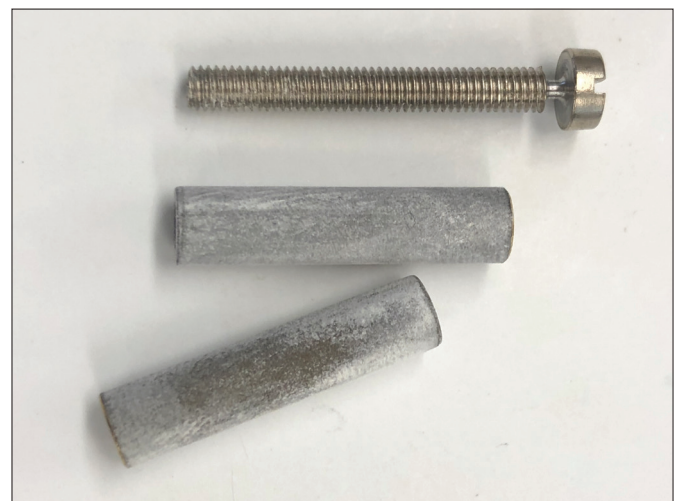
Finally, I found a most unusual surface on the two standoffs holding the movement. When I first removed them, I thought they were ceramic insulators, because of their pale grey-white and powdery surface, **Figure 11**. Later when I cleaned them, I realised they are actually metal of an oxidised-copper colour. The white powdery surface simply brushed off. Was this the result of galvanic action with the aluminium dial? The wooden case was clean without signs of damp, oxides or deterioration.

Figure 11. The two metal standoffs keeping the movement from the dial were covered in a peculiar pale powdery dust.

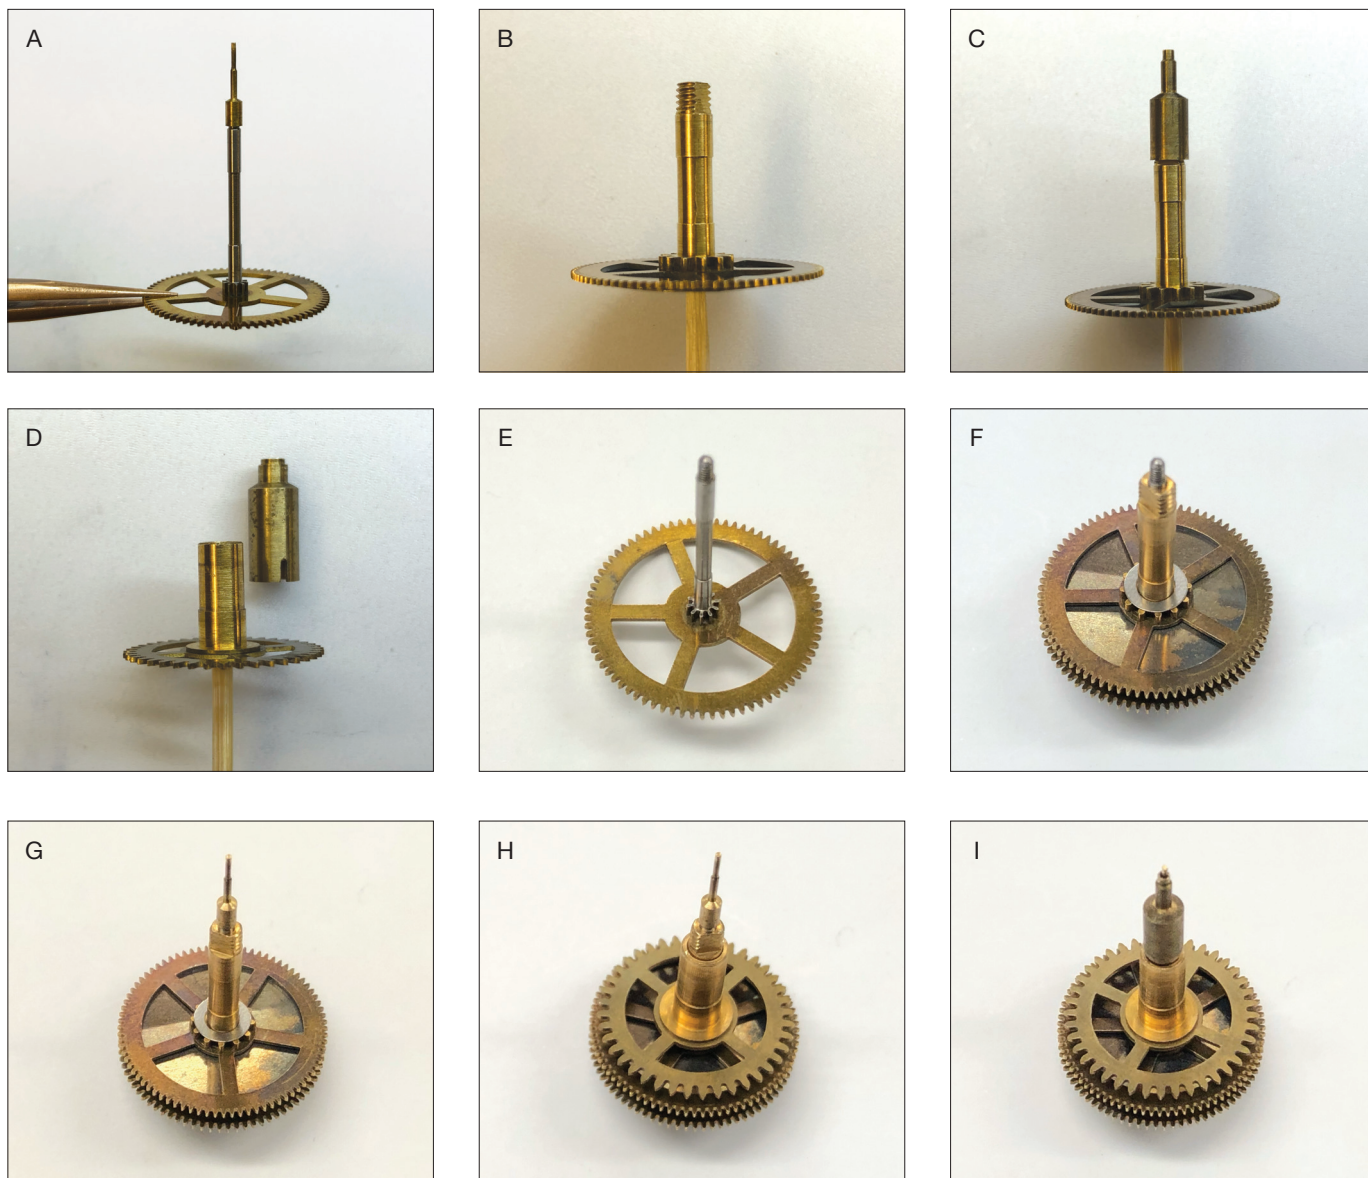
Another unusual feature is that the pipes and arbors for the hands were all extended to clear the dial. Reassembly of these extensions was straightforward if rather labyrinthine. The seconds and minute arbors are first assembled. Next the seconds extension is screwed on. Next the hour wheel is added, and only after this can the minute extensions be screwed on. Finally the hour extension (whose tip is narrower than the body) is pressed on over the whole lot. **Figures 10A–I** illustrate the steps.

Figure 10. The motion work needs considered reassembly due to the peculiar way that the arbors have been lengthened in order to accommodate the case. A–D show how each arbor’s extension is fitted. E–I show the assembly. The minute arbor is first placed over the seconds arbor. Then the seconds extension is screwed on. Then the hour wheel is installed, and following this, the minutes-extension. Finally, the hour extension can be pressed into place.
