The Horological Journal

Problems with Snails!

New Snails for Two Eight-day Rack Strike Longcase Clocks

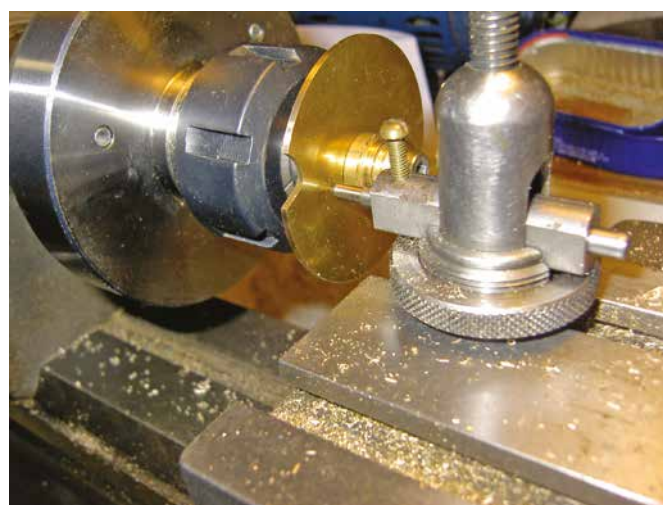
Figure 1. Using a scribe mounted in the tool-post.

the rack to drop perfectly to its position for one o'clock. It was then divided into 12 sectors using the lathe index with a scribe mounted in the tool post, **Figures 1 and 2**. Alternatively, a protractor could be used as absolute accuracy is not necessary for this.

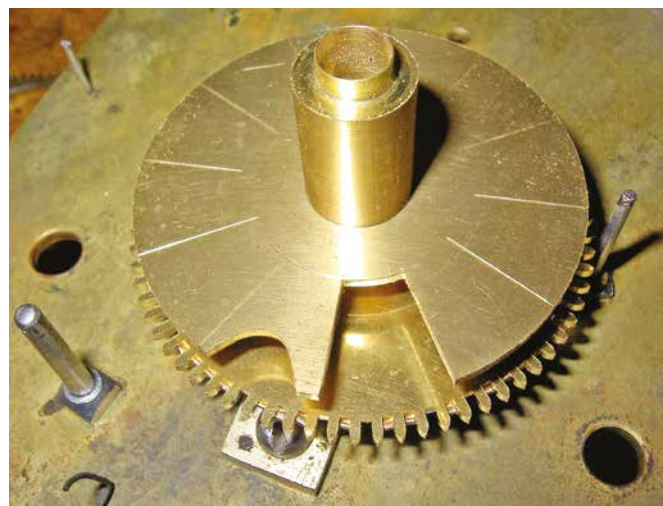
Figure 2. The snail disc was divided into 12 sectors. The last step on the snail was removed using a piercing saw. (The semi-circular cut-out is a leftover from another project).

Using a piercing saw, this last step on the snail was now removed, cutting a little away from the line and finishing it to perfection with a file, testing it frequently on the clock, **Figure 2**.

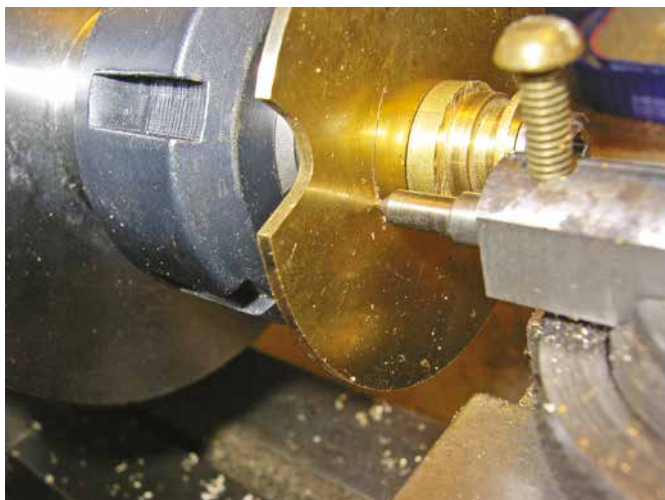
Figure 3. A circular mark for the 12 o'clock step position was made with the tool-post scribe.

for 12 o'clock was found by setting the rack-hook in the 12 o'clock position on the rack and scribing a small mark on the disc at the active side of the rack tail pin, not using the pin itself for marking. The disc was now put back on the temporary arbor in the lathe and a true circular mark made with the tool-post scribe, **Figure 3**.

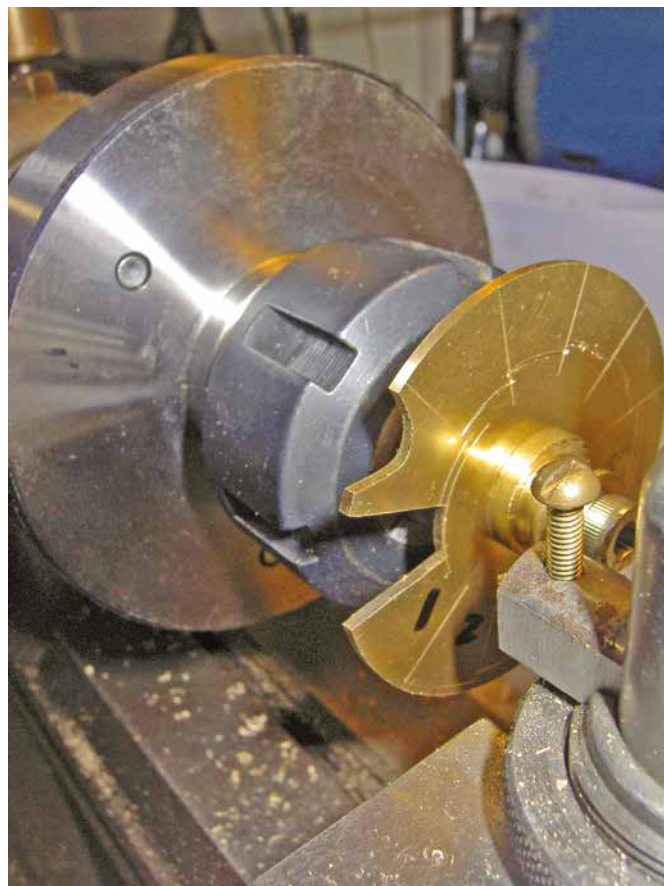
Figure 5. The tool-post scribe was used to mark each of the steps on the snail.

millimetre. It was then quite a simple operation to scribe all the steps on the snail, **Figure 5**.

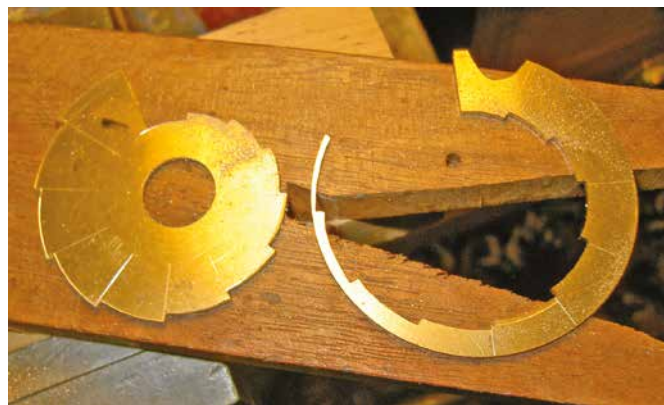
Figure 6. The snail profile was cut out using a piercing saw.

The snail profile was now cut out using a piercing saw, being careful to leave the work over-size by cutting just shy of the line throughout, **Figure 6**.

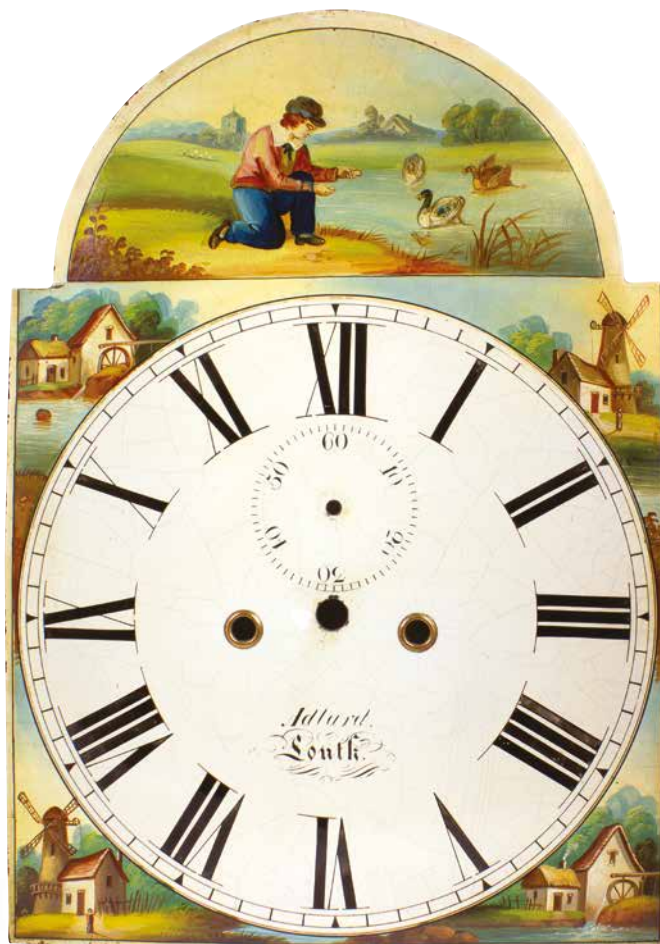
Figure 8. The dial signed Adlard of Louth.
