The Horological Journal

Course Review

Repair, Restoration and Conservation of Antique Clocks
Course at Upton Hall, 6–10 June, 2022

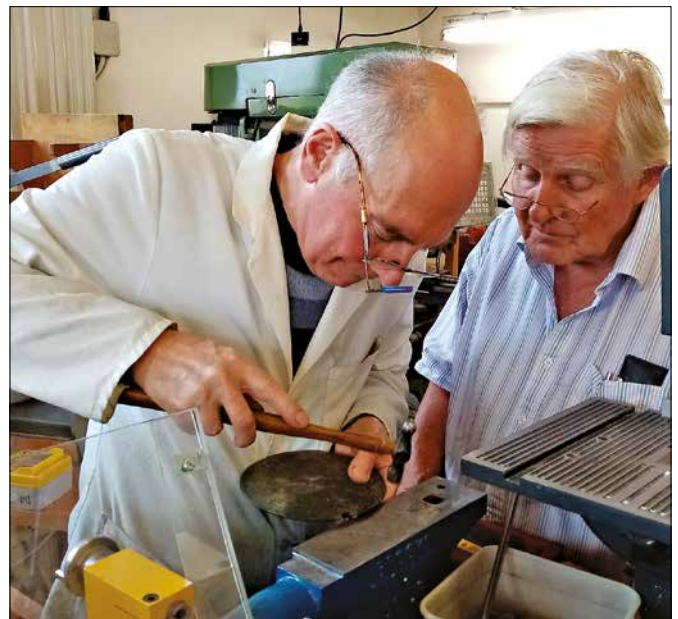
Another problem was that the heavy lead-filled pendulum bob has been dropped at some time, resulting in damage to the lower part of the shells which had been forced apart. Gentle hammer work, **Figure 1**, sorted this and the shells were held together with small steel rivets.

Figure 1. John Reynolds and Christopher Kevill-Davies repair a pendulum bob.

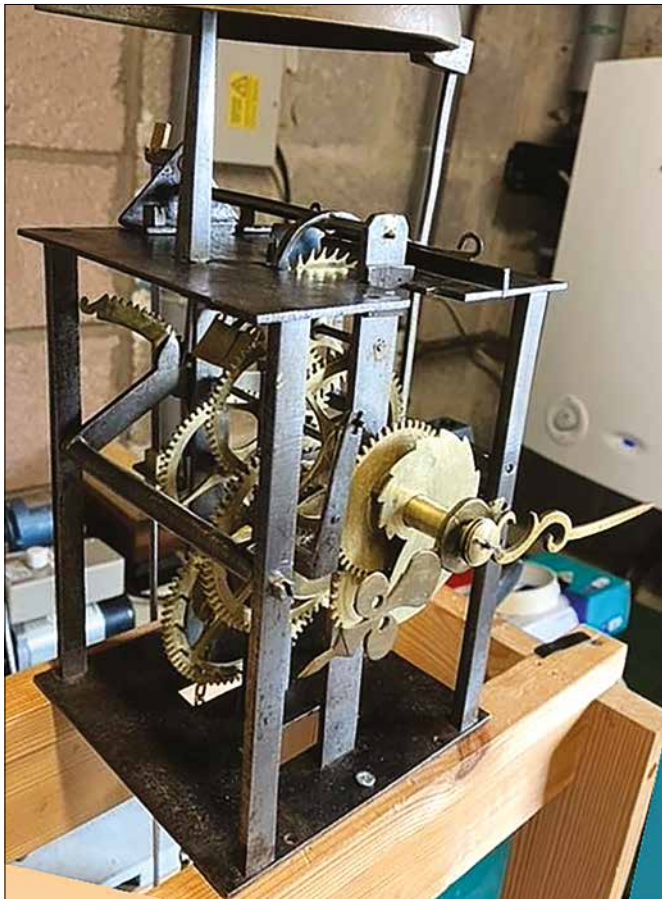
Ian brought in a rare 30-hour Comtoise clock movement of *circa* 1815 vintage, in which the pulleys were badly worn. After cleaning the movement, he made new pulleys, cut a new ratchet wheel on the wheel-cutting engine, and repaired the click spring, **Figure 2**.

Figure 2. Ian Harris's restored 30-hour Comtoise movement.

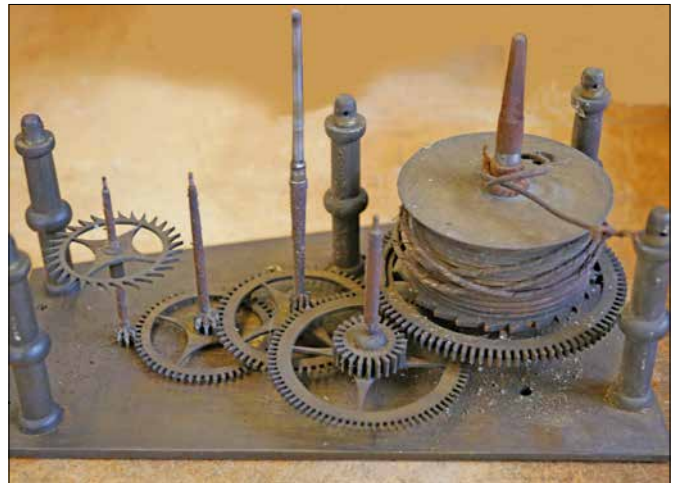
Kevan worked on a recently acquired weight-driven clock movement which was something of a mystery, **Figure 3**. It has

tapered plates, a false plate for a metal dial and a rear take-off from the motion work to run a secondary dial. Perhaps it was originally a station or pavilion clock?

An intermediate wheel and pinion between the great wheel and the centre arbor pinion ensure a shorter weight drop, most likely for a wall mounted case, and a train count revealed that the clock was designed for a seconds pendulum. Apart from the obvious need for cleaning, several teeth were missing from the hour wheel, the third wheel had broken crossings and had been badly repaired, and the end of the pendulum crutch was missing. He decided to cut a new hour wheel, but the rim of the third wheel was rescued and attached to a new crossed-out centre.

Figure 3. Kevan Lomas's movement before cleaning.

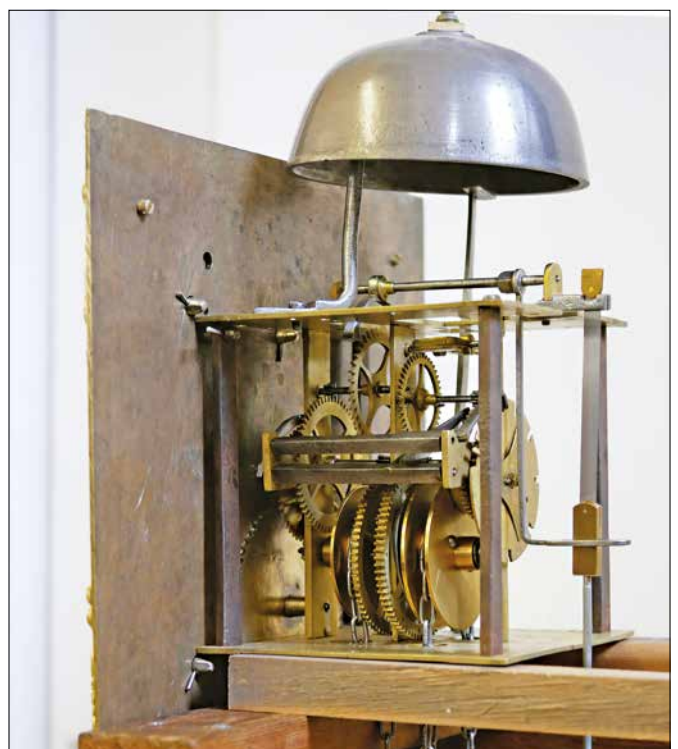
The posted frame movement, **Figure 4**, had probably been recycled from a lantern clock, as evidenced by the holes for gallery frets in the top plate and pivot holes for side doors in both top and bottom plates. It was in reasonable condition, but needed cleaning and quite a lot of bushing. A new bell hammer was made to replace the poorly repaired original, and as the weight chain was missing, new sprocket centres were fitted between the pulley shrouds for a new chain. A train count established that a 22 in ($\frac{3}{4}$ second) pendulum was required, and testing revealed that the clock would now run quite reliably on a 4lb weight.

Figure 4. The author's restored movement by William Aris.

Finally, the 10in brass dial responded well to cleaning and re-silvering. The hand and date pointer were blued using the excellent bluing box presented to the clock workshop at Upton Hall by the Manchester Branch (see 'A Kind of Blue', *HJ* April 2022, p139). Set at 300°C, it produced perfect results,
